The Hit, the Teardown and the Rebuild of my 2004 Mazdaspeed Miata

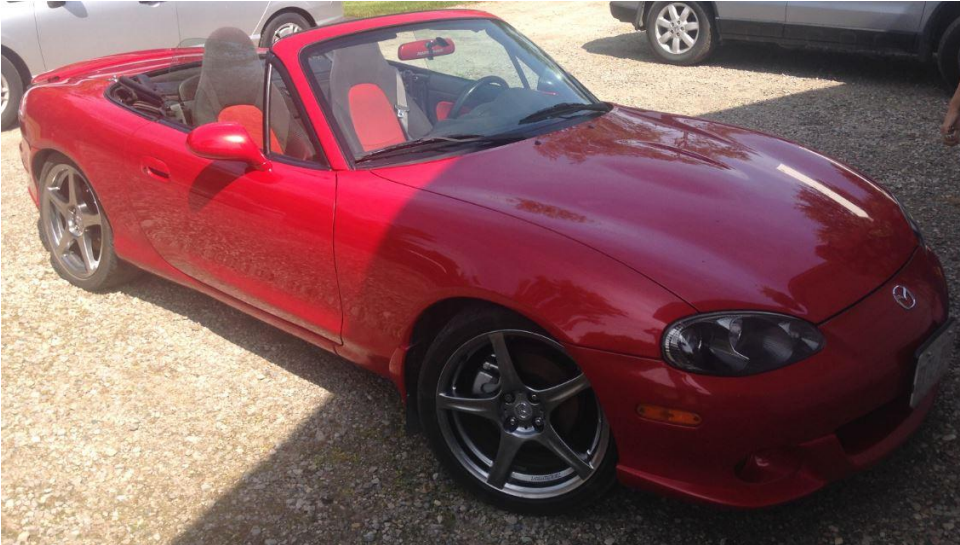
This was the pre-collision state of my MSM August 27th 2017. I had just had the rocker panels fixed the previous year. If I had only known what the future held in store !!!!

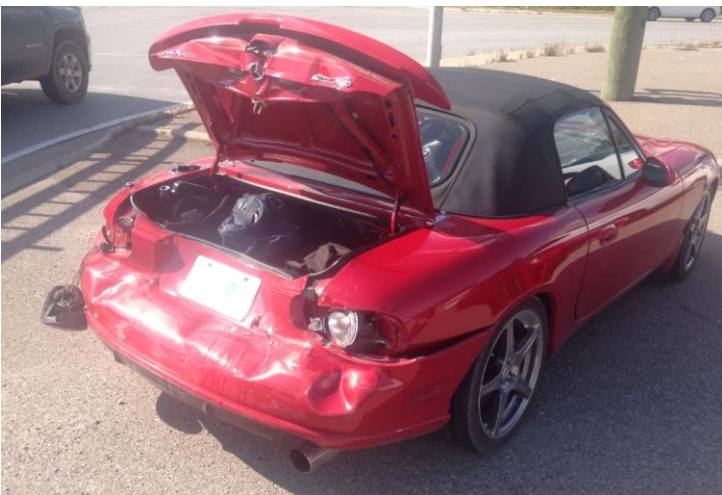
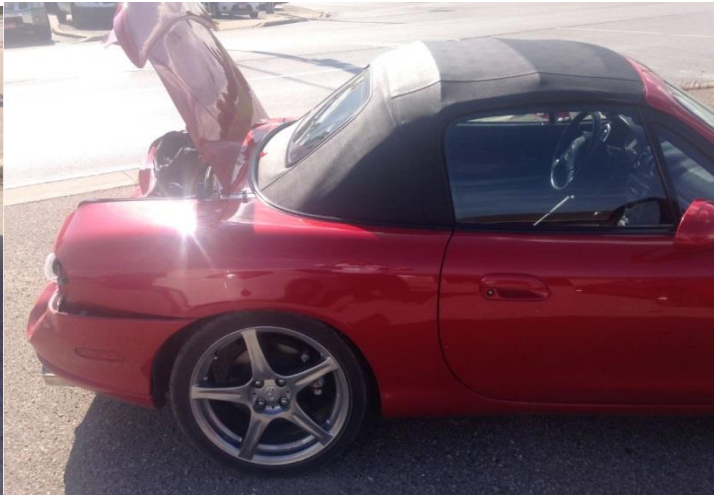
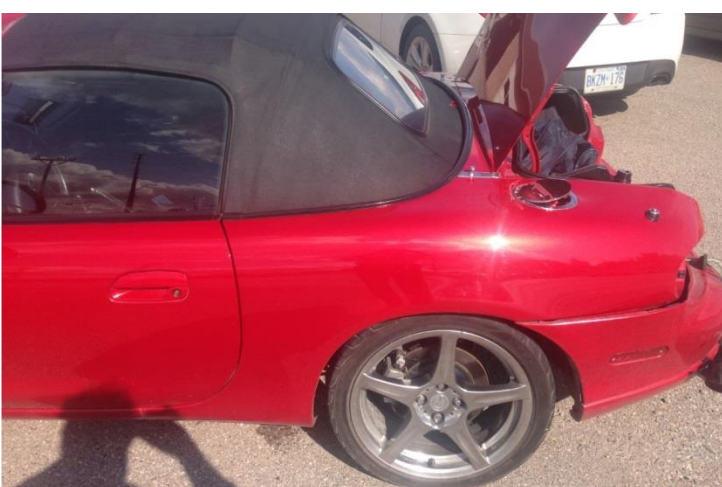
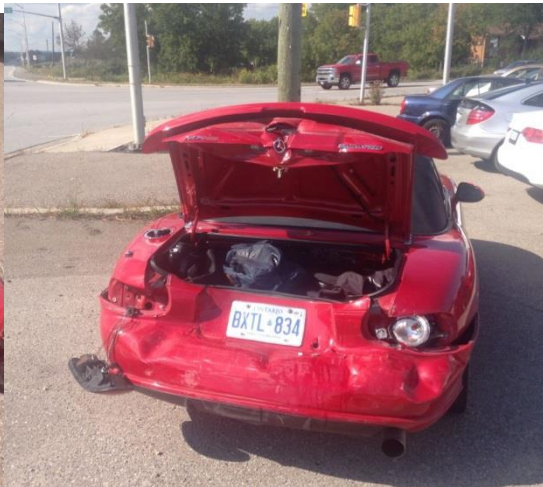
Right after the collision Sept 5th 2017– Mustang driver hit me from behind. He was too busy gawking at accident on other side of the road (where police and tow trucks were already in attendance with flashing lights).

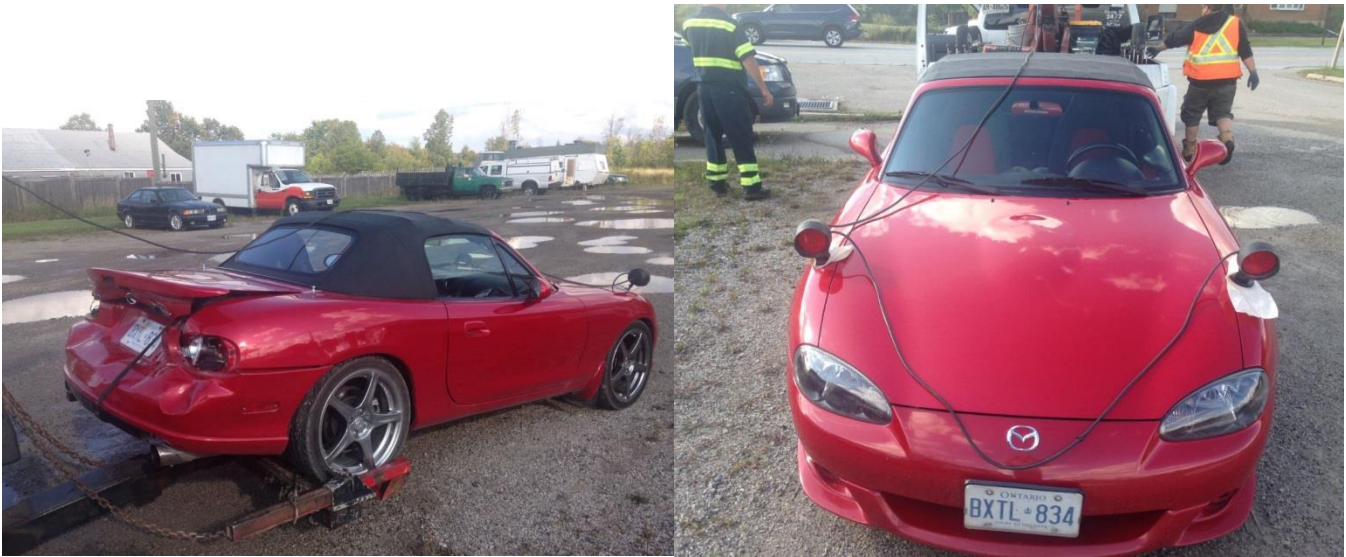
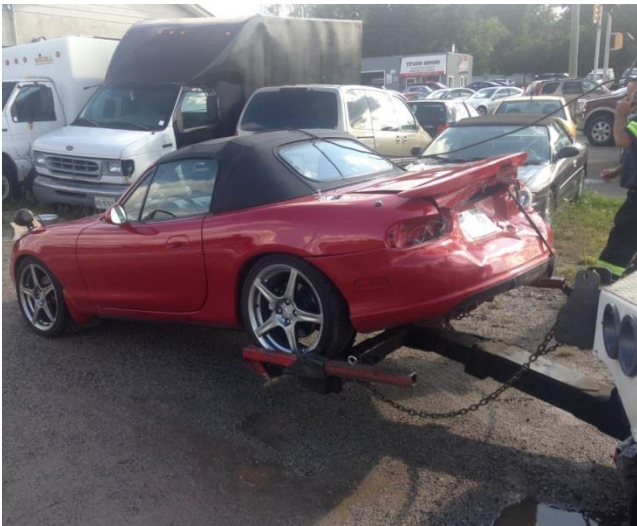
The tow up to the body shop, Theaker's Collision near where I live. The tow truck was already on scene due to the other accident. Police and tow truck operator witnessed the hit on my car.

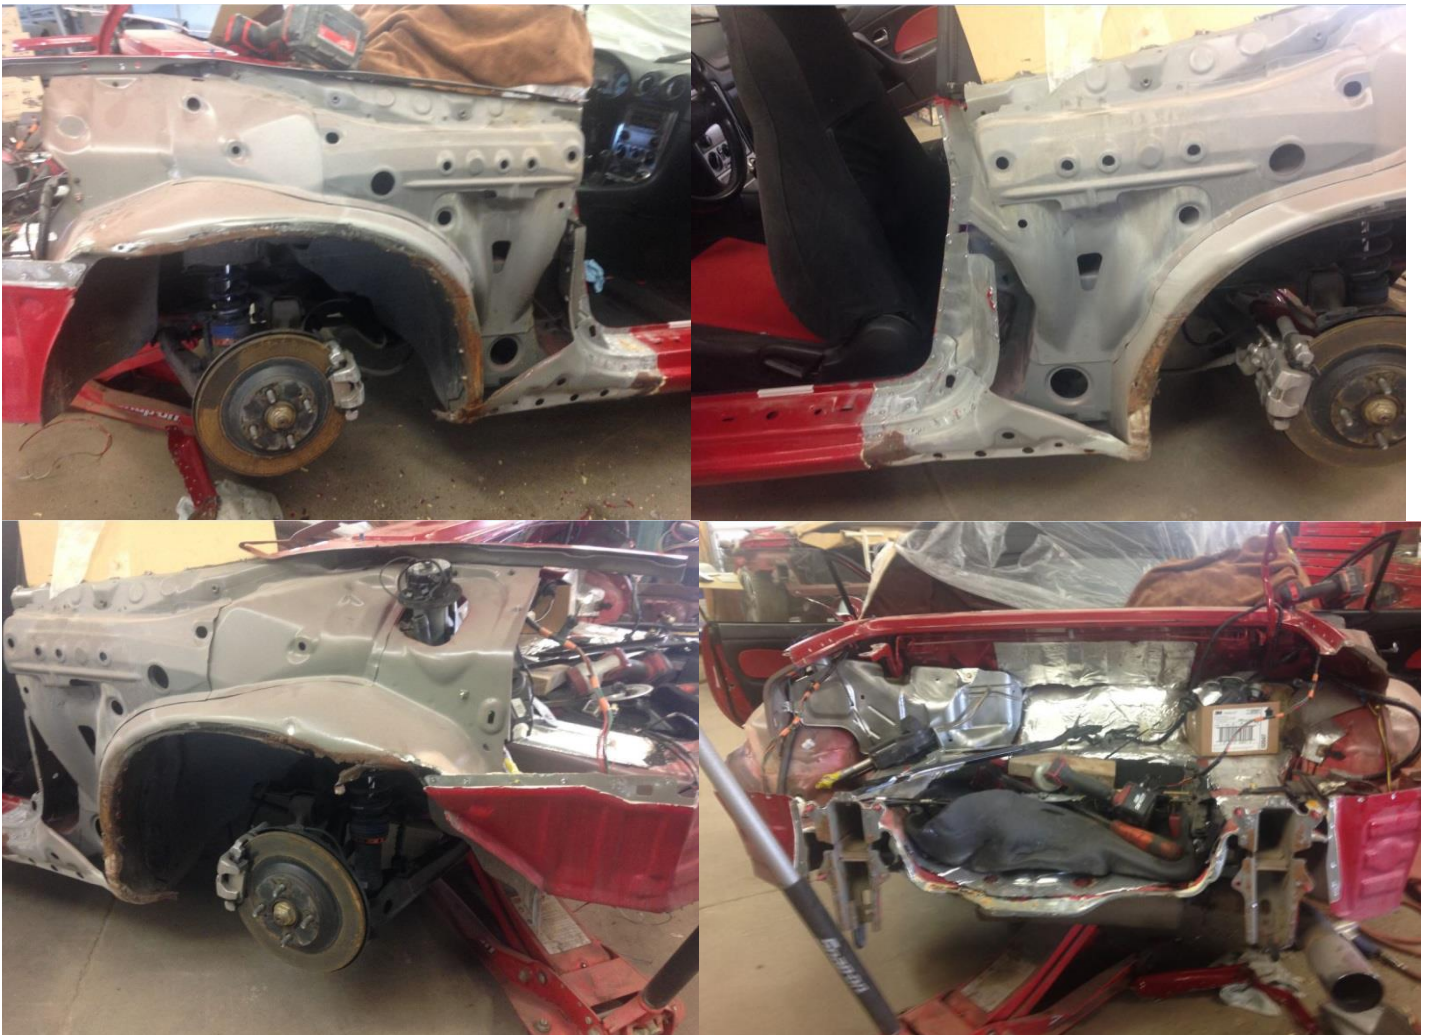
Insurance gave the go ahead on my car after inspection a few days later. They were very good about the repairs. The teardown of damaged panels – Sept 28th 2017

Note the rust in the arch lip and rocker areas. At least it was going to be thoroughly taken care off. It was not visible pre-collision. New metal was welded in during the rebuild where needed

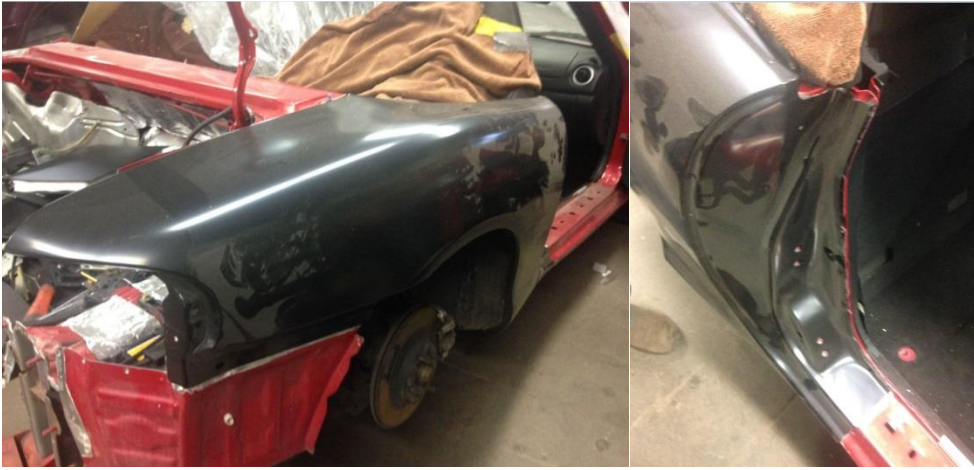
Fitting of the rear quarters underway Oct 4th 2017. They have to be aligned along with trunk lid and rear panel for accurate fitting. All new sheet metal panels were obtained from Mazda. So all totally OEM.

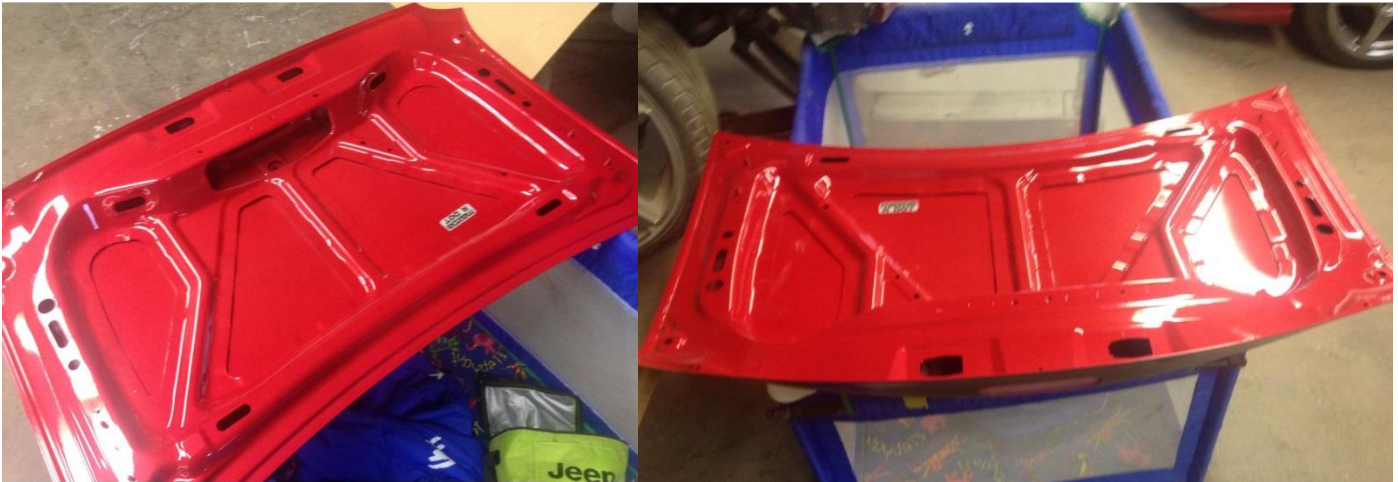
Underside of trunk lid was painted so it could be attached to new hinges on car for fitting.

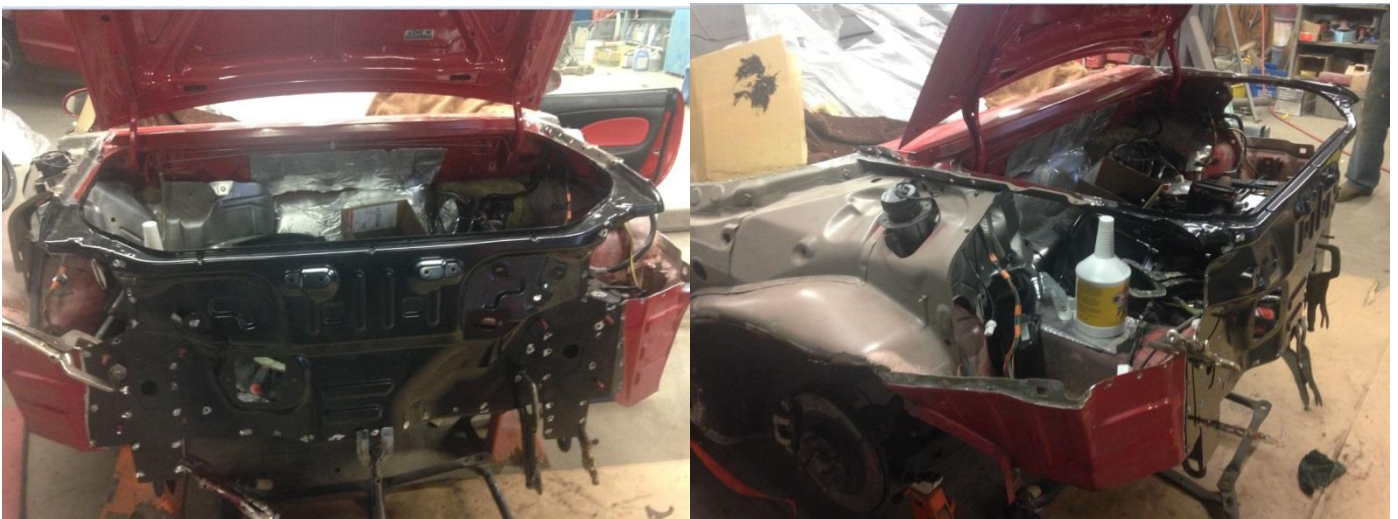
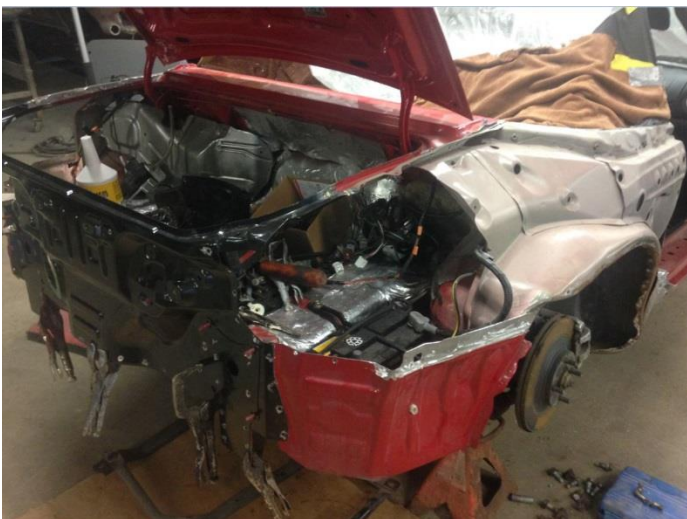
New OEM rear panel and corner braces are fitted to car to do alignment of them with quarters and trunk lid – Oct 11th 2017. Then parts were brazed in place and then drilled for MIG spot welds to frame and adjacent panels.

Rear quarters were then put in place and welded and glued to existing panels. High strength adhesive was used along arches and door pillar flanges. This required very accurate fitting and alignment of the panels. No chance of water getting in and rusting new arch pinch flanges like it did on originals with just spot welds.

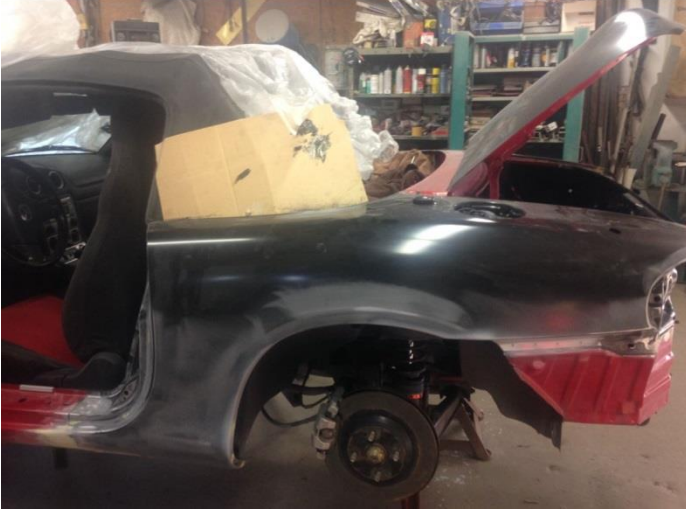
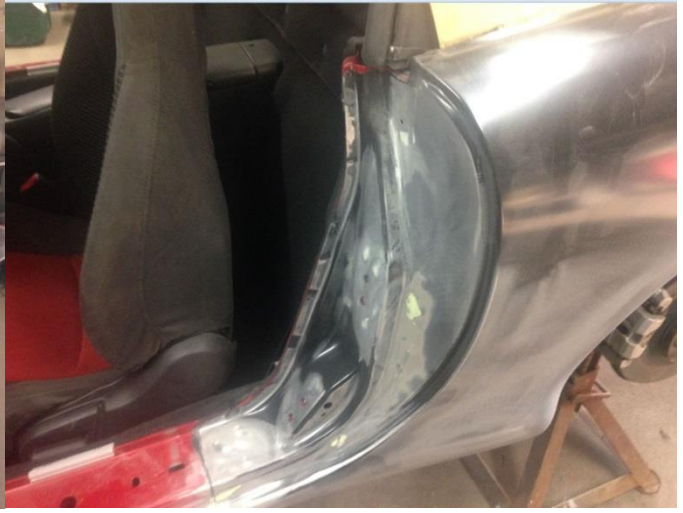
Driver side rear quarter is now permanently in place – Oct 17th 2017.

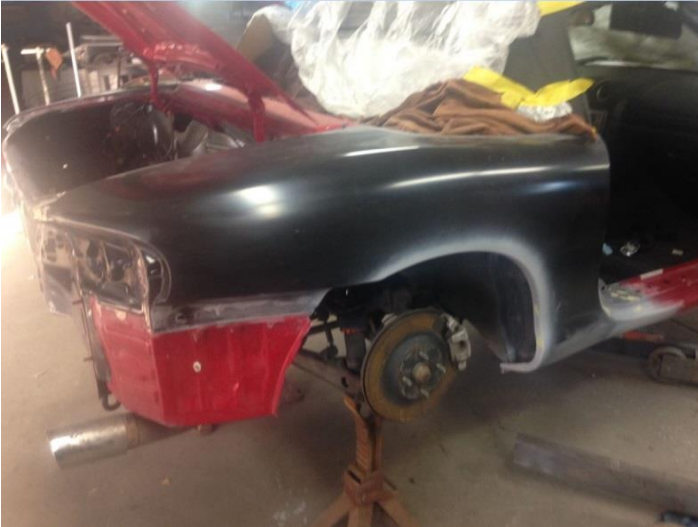
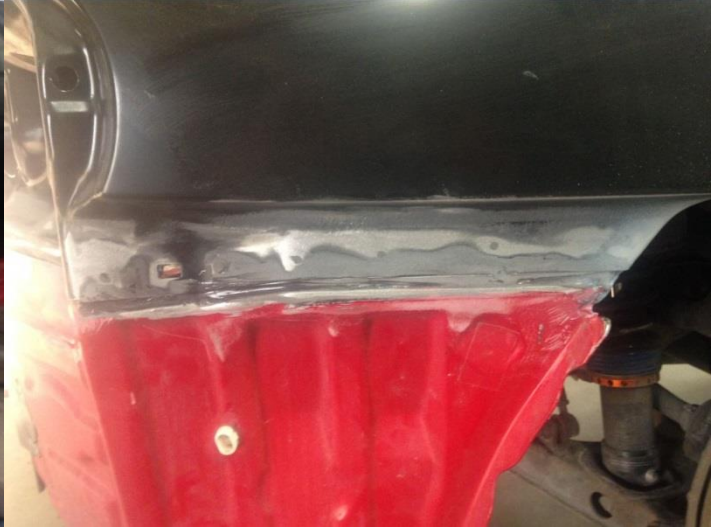
Passenger side is also permanently in place. High strength adhesive bonding was used for much of it.

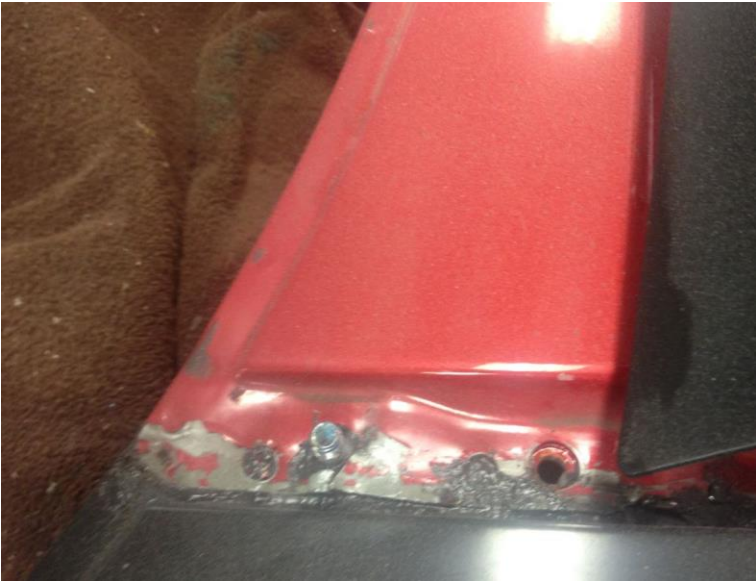
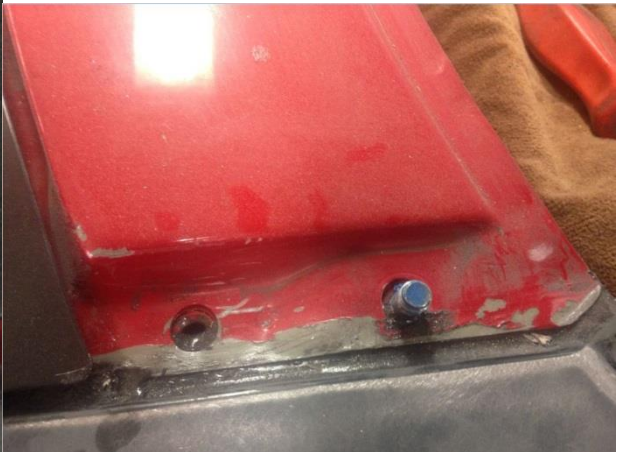
Quarters attached to panel behind top in Frankenstein bolt area with high strength adhesive. Spot welds had to be drilled out to lift flanges so fenders could be fitted underneath.

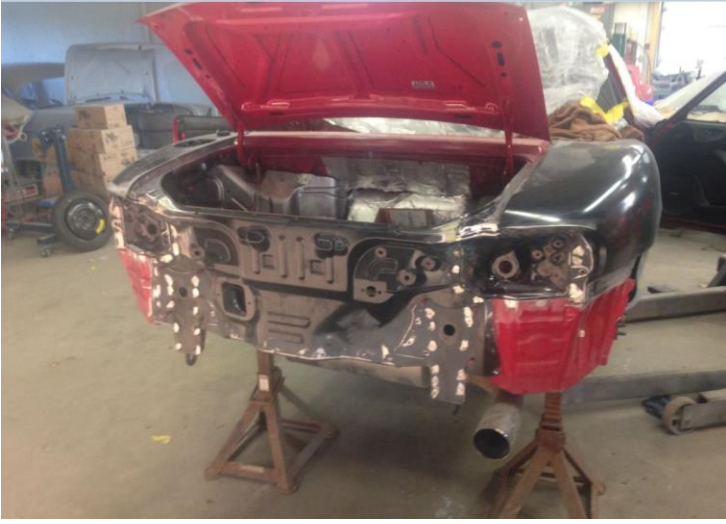
Rear panel now permanently in place and attached to rear quarters. It's beginning to look whole again.

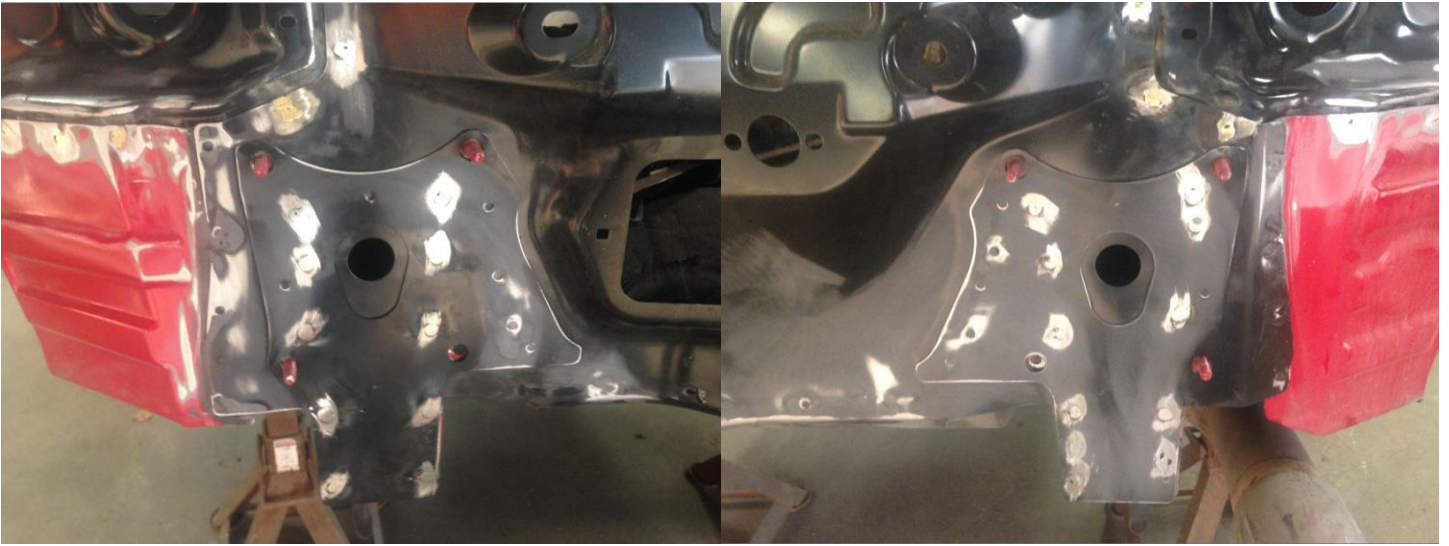
Rear panel welding details, left and right.

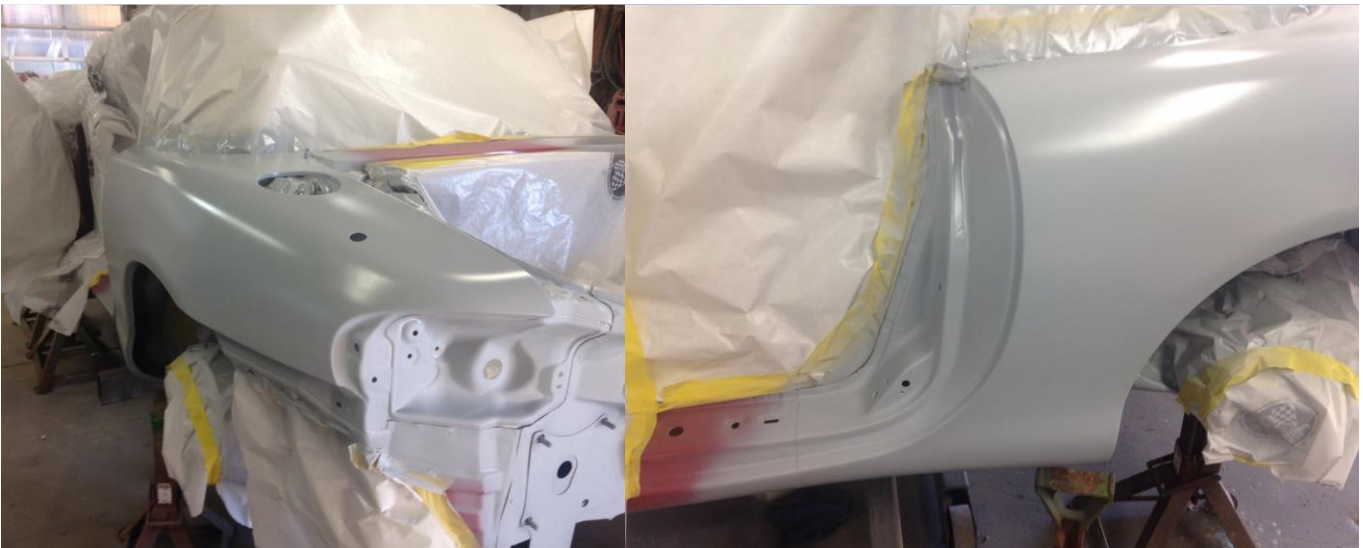
Driver's side rear quarter now primed in 2 part epoxy – Oct 20th 2017. It will be blocked down to remove imperfections and any orange peel texture.

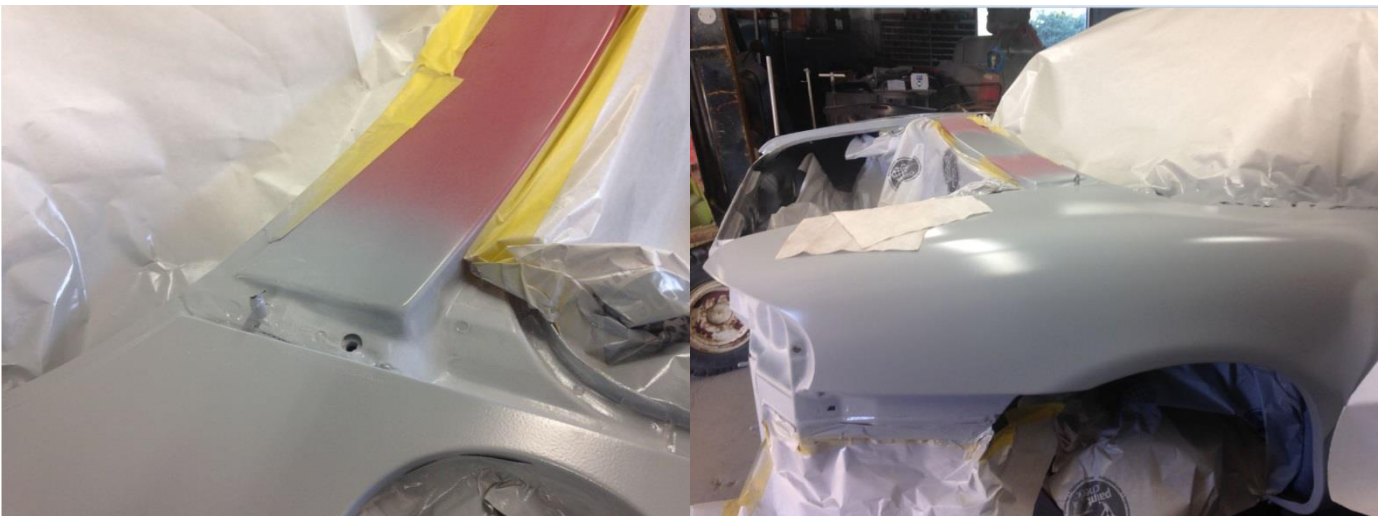
Same with passenger rear quarter. BTW the panel right behind the top between the Frankenstein bolts is NLA from Mazda. Work had to be done carefully not to damage it.

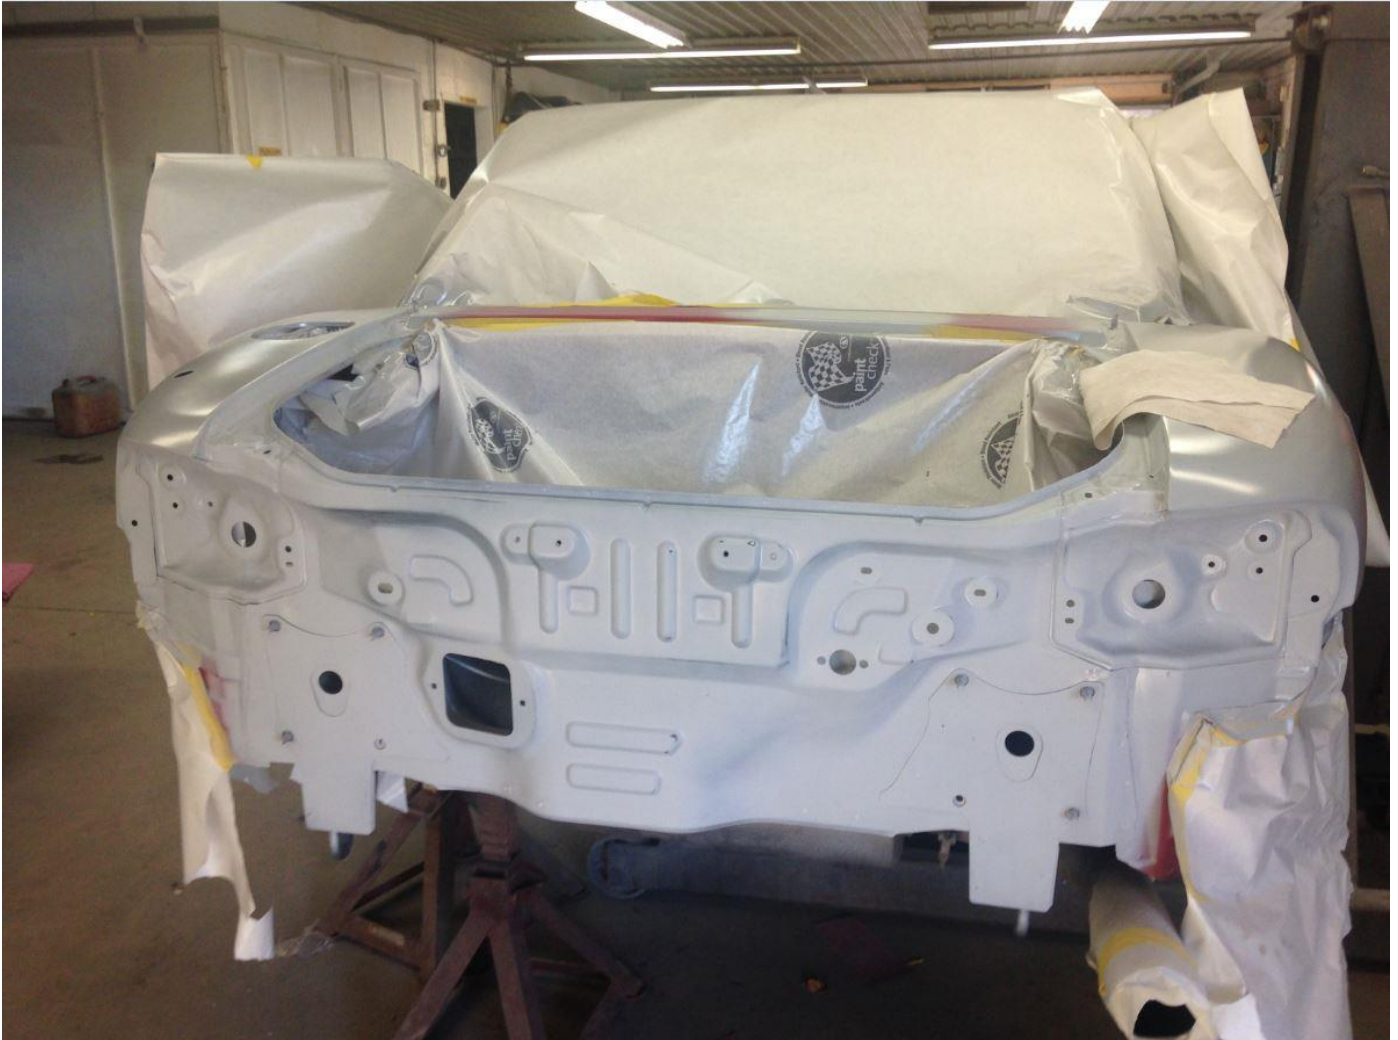
The rear panel primed.

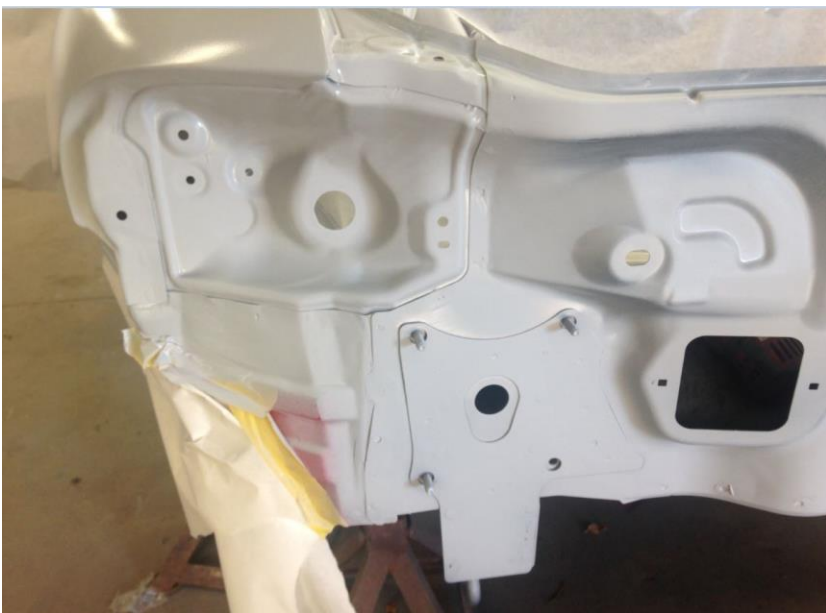
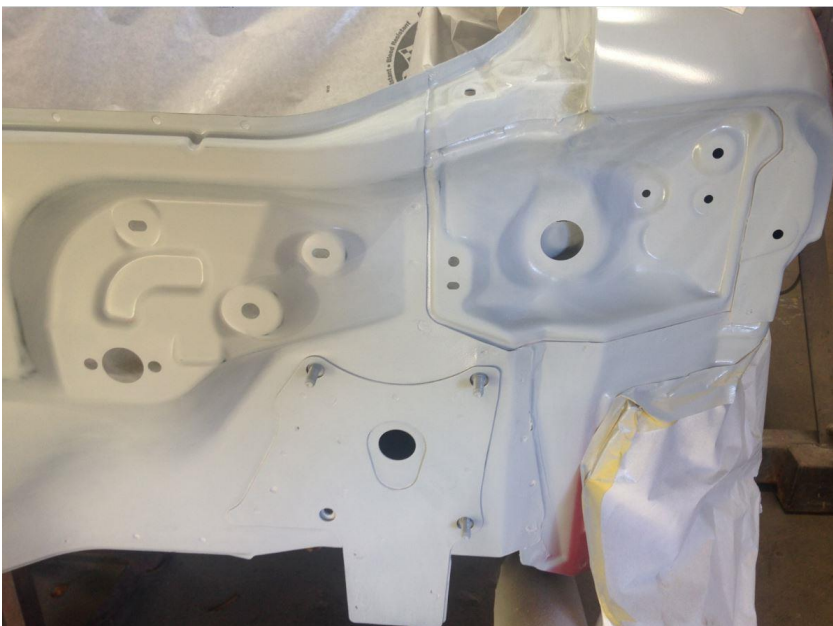
Detail photos of the left and right rear panel areas. The square opening is for the air release flap. New pone of those was needed too.

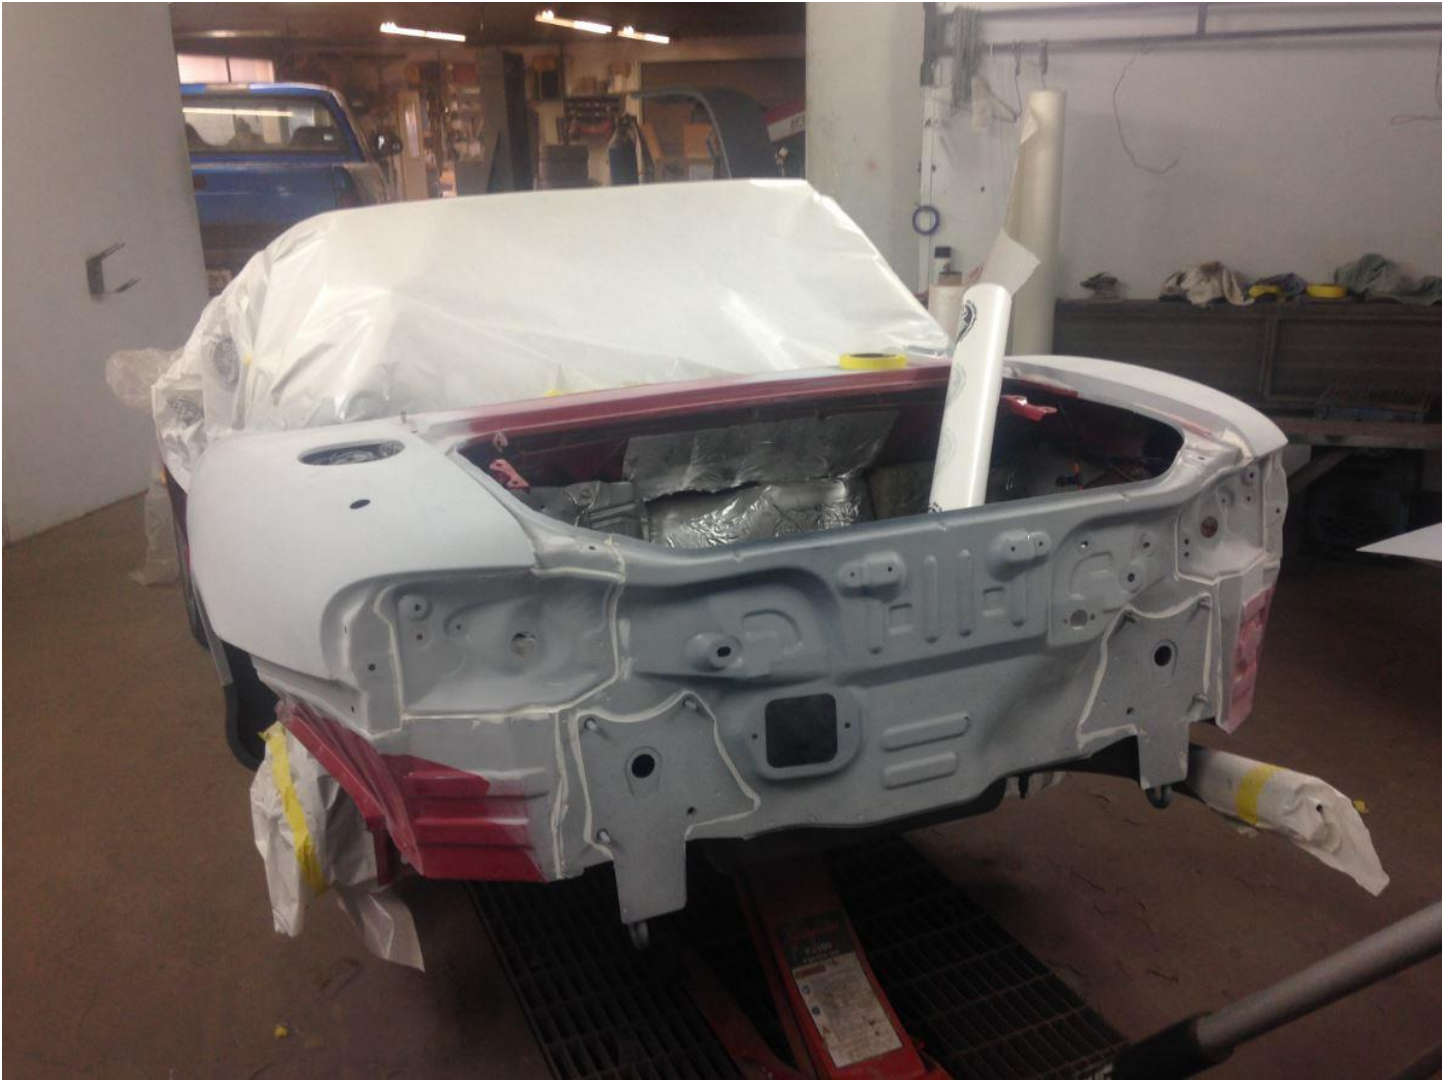
Rear quarters blocked down and ready for paint and all seams now sealed Oct 26th 2017.

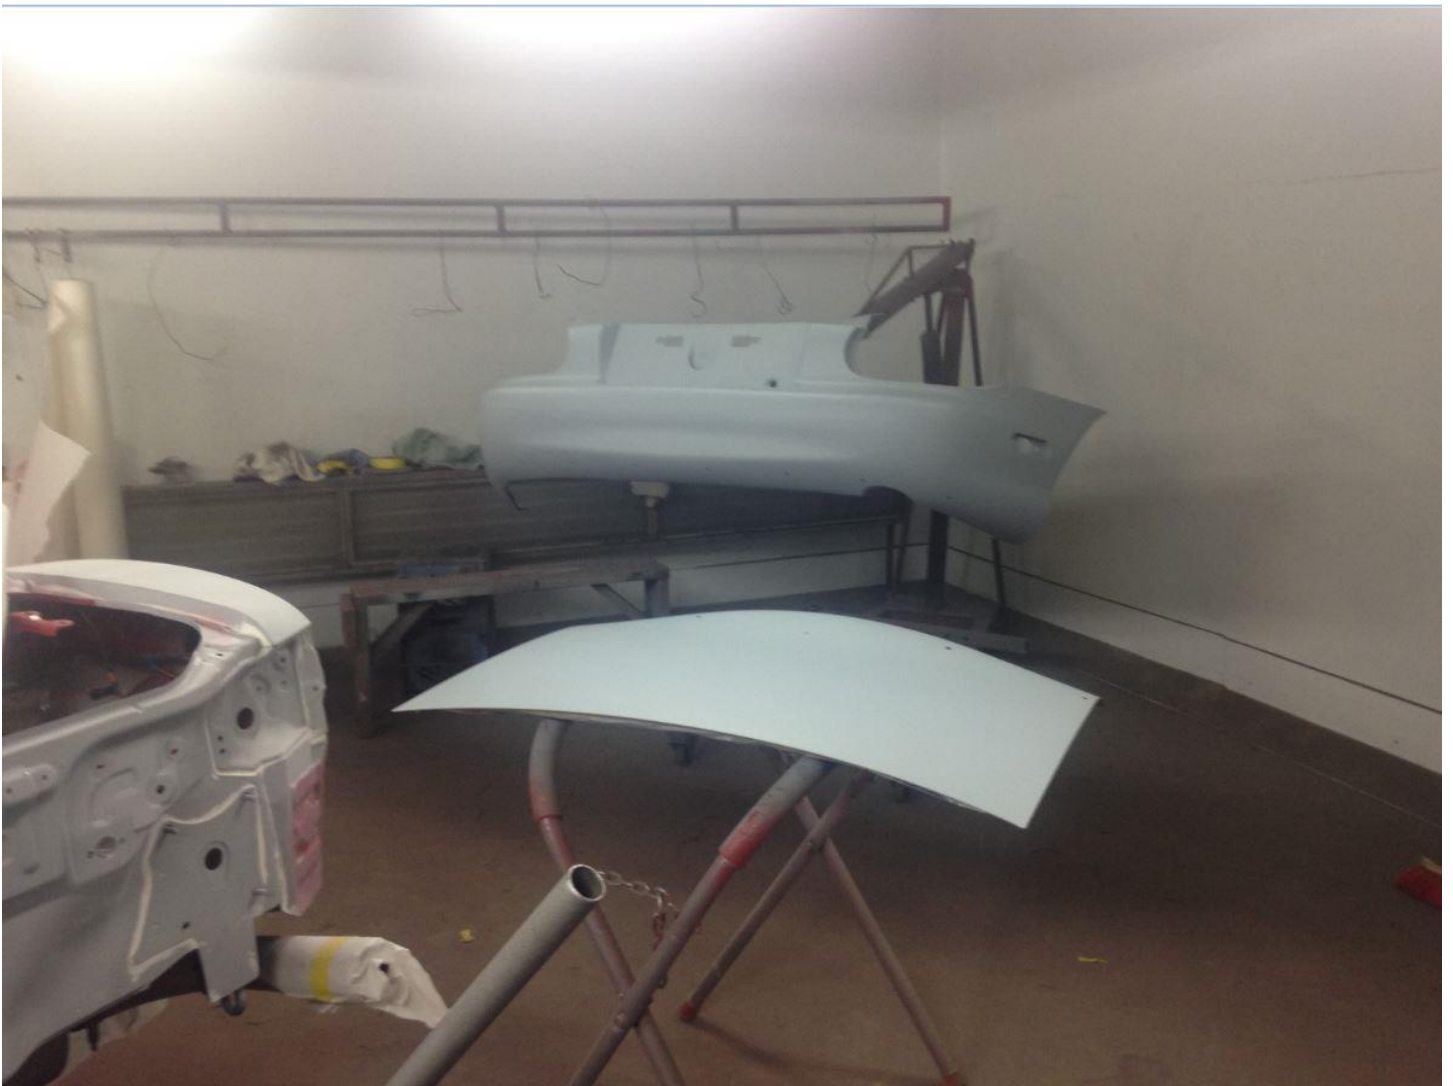
Trunk lid and bumper cover epoxy primed and ready for blocking to prepare for painting Oct 26th 2017.

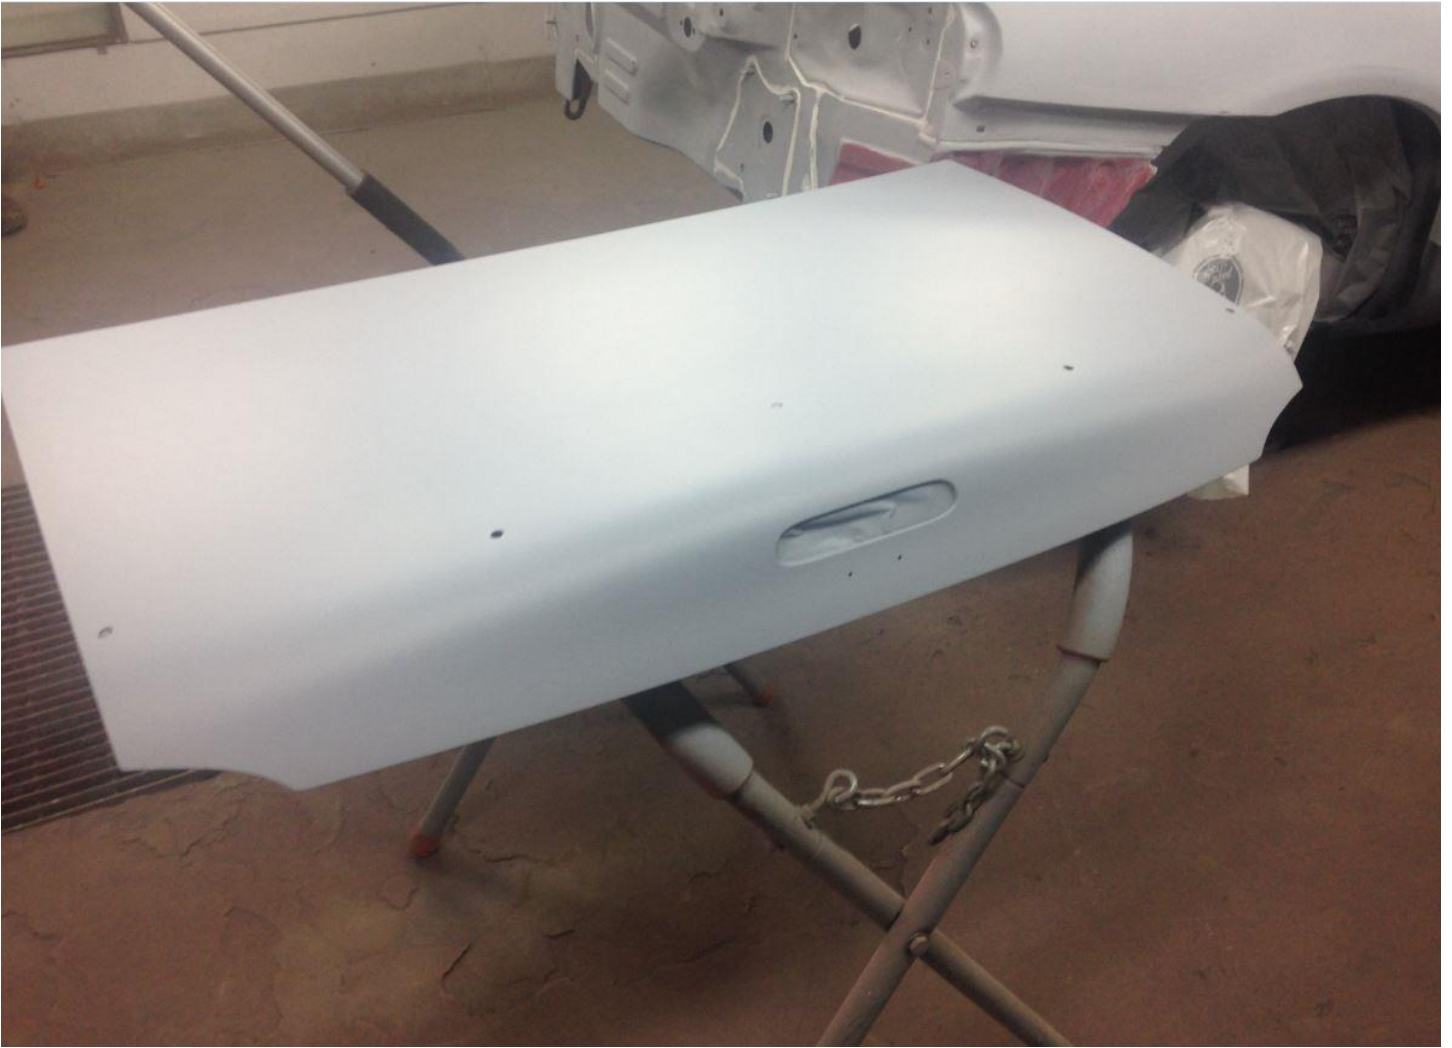
Note holes for mounting rear spoiler. It came that way from Mazda. OEM spoiler is also NLA from Mazda so minor repairs were made to existing one.

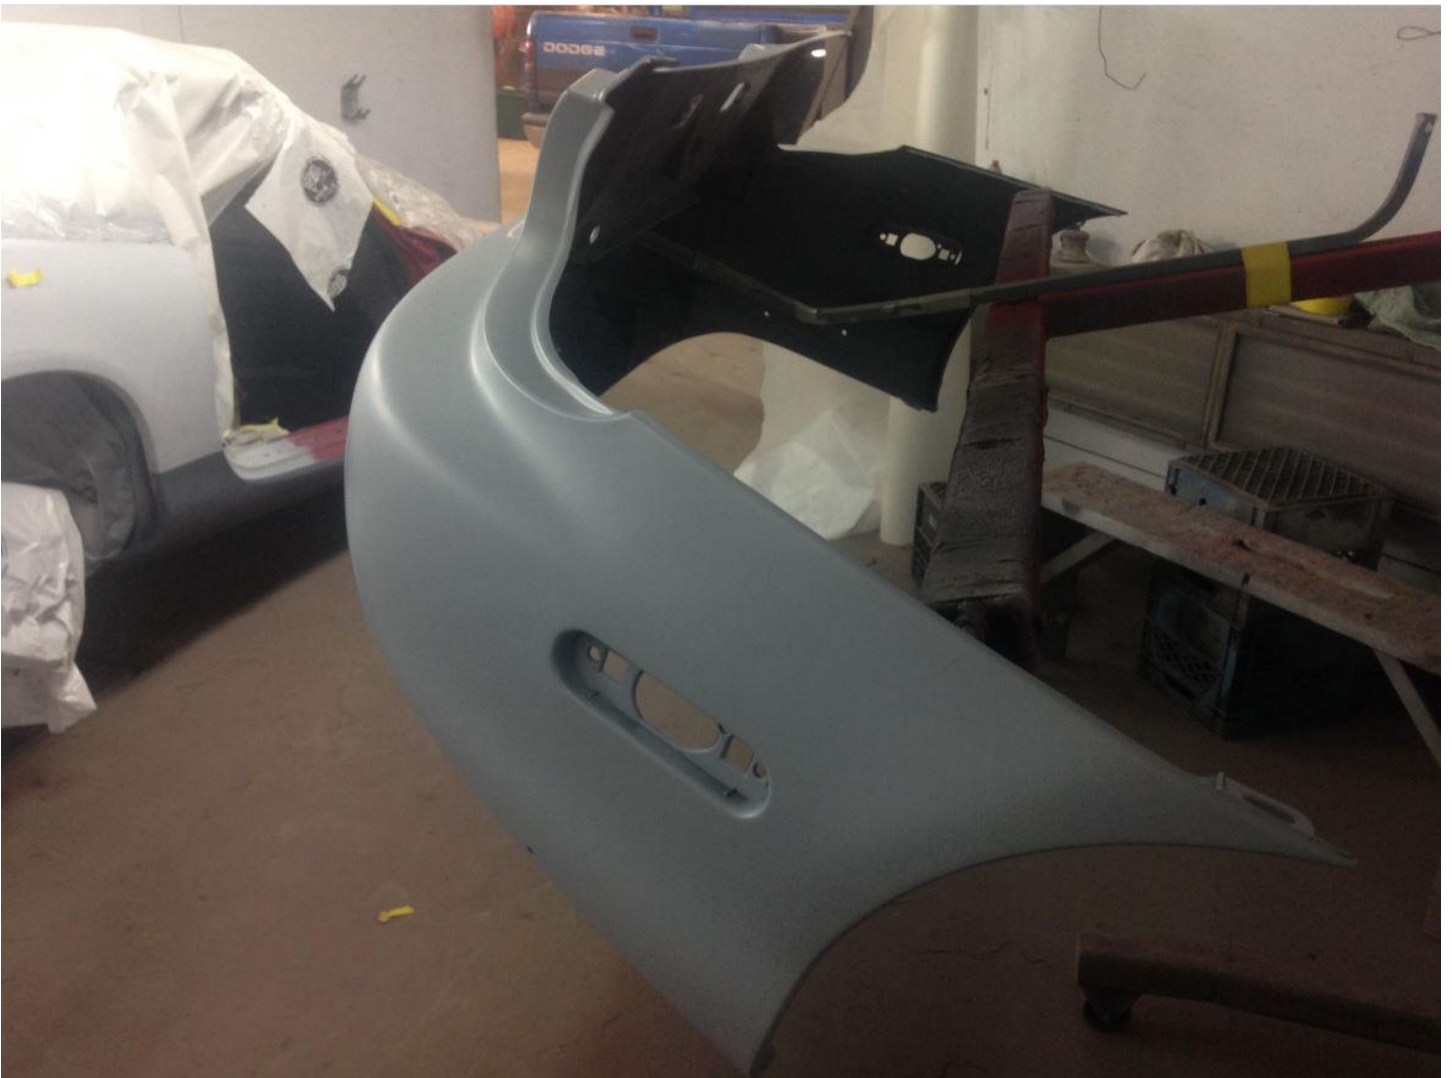
Another view of the new bumper now primed with epoxy primer.

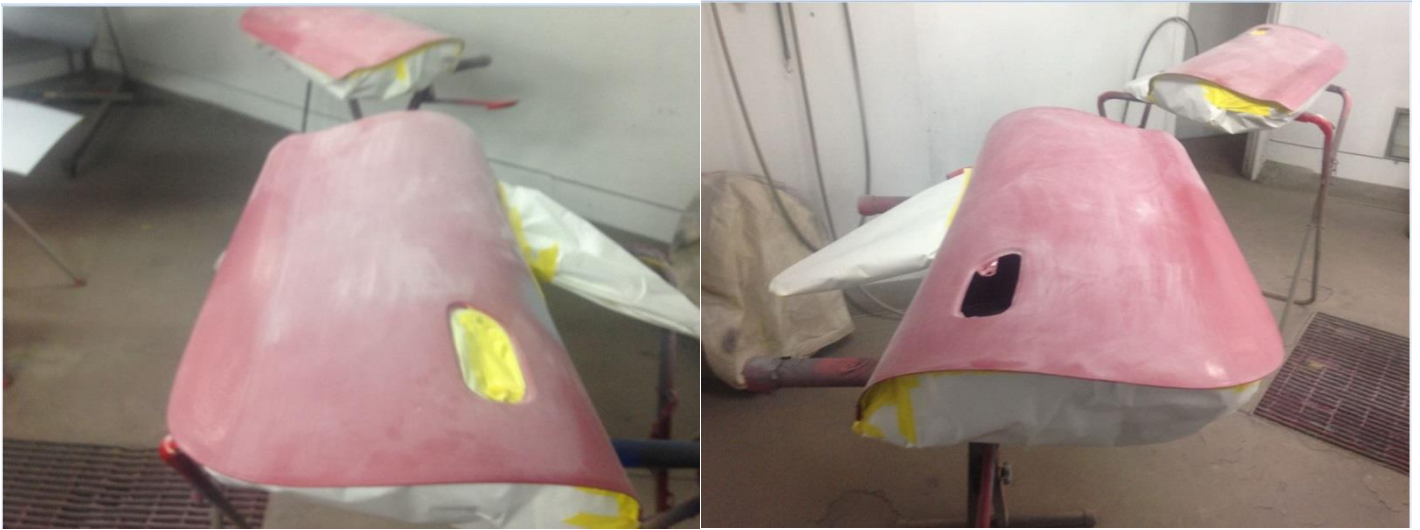
Doors scuffed up and ready for paint.
