The Hit, the Teardown and the Rebuild of my 2004 Mazdaspeed Miata

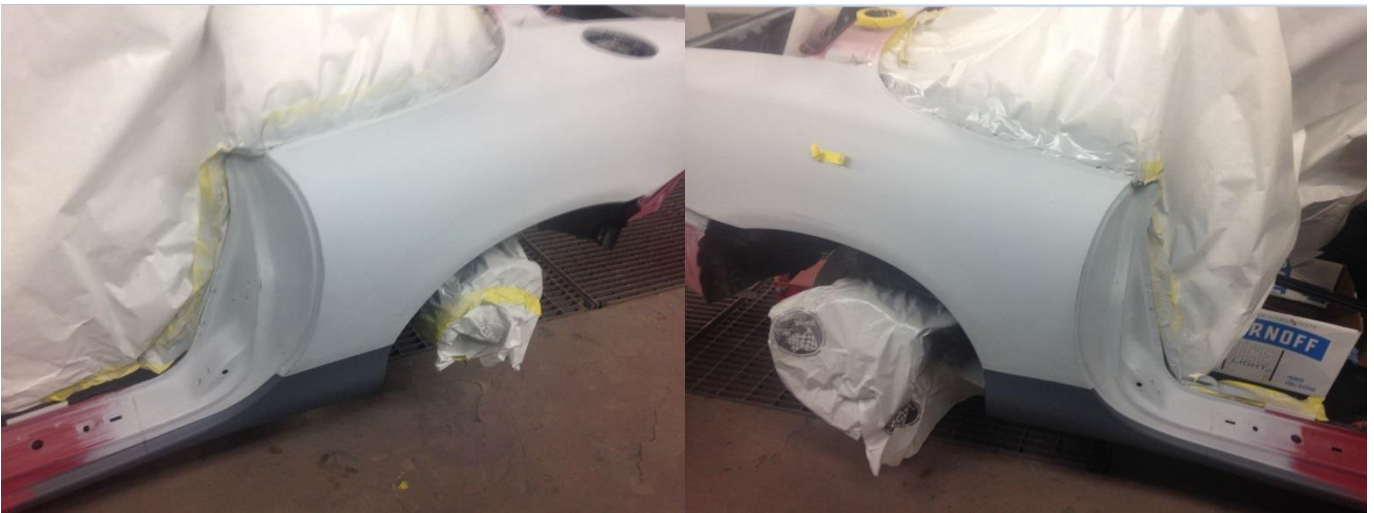
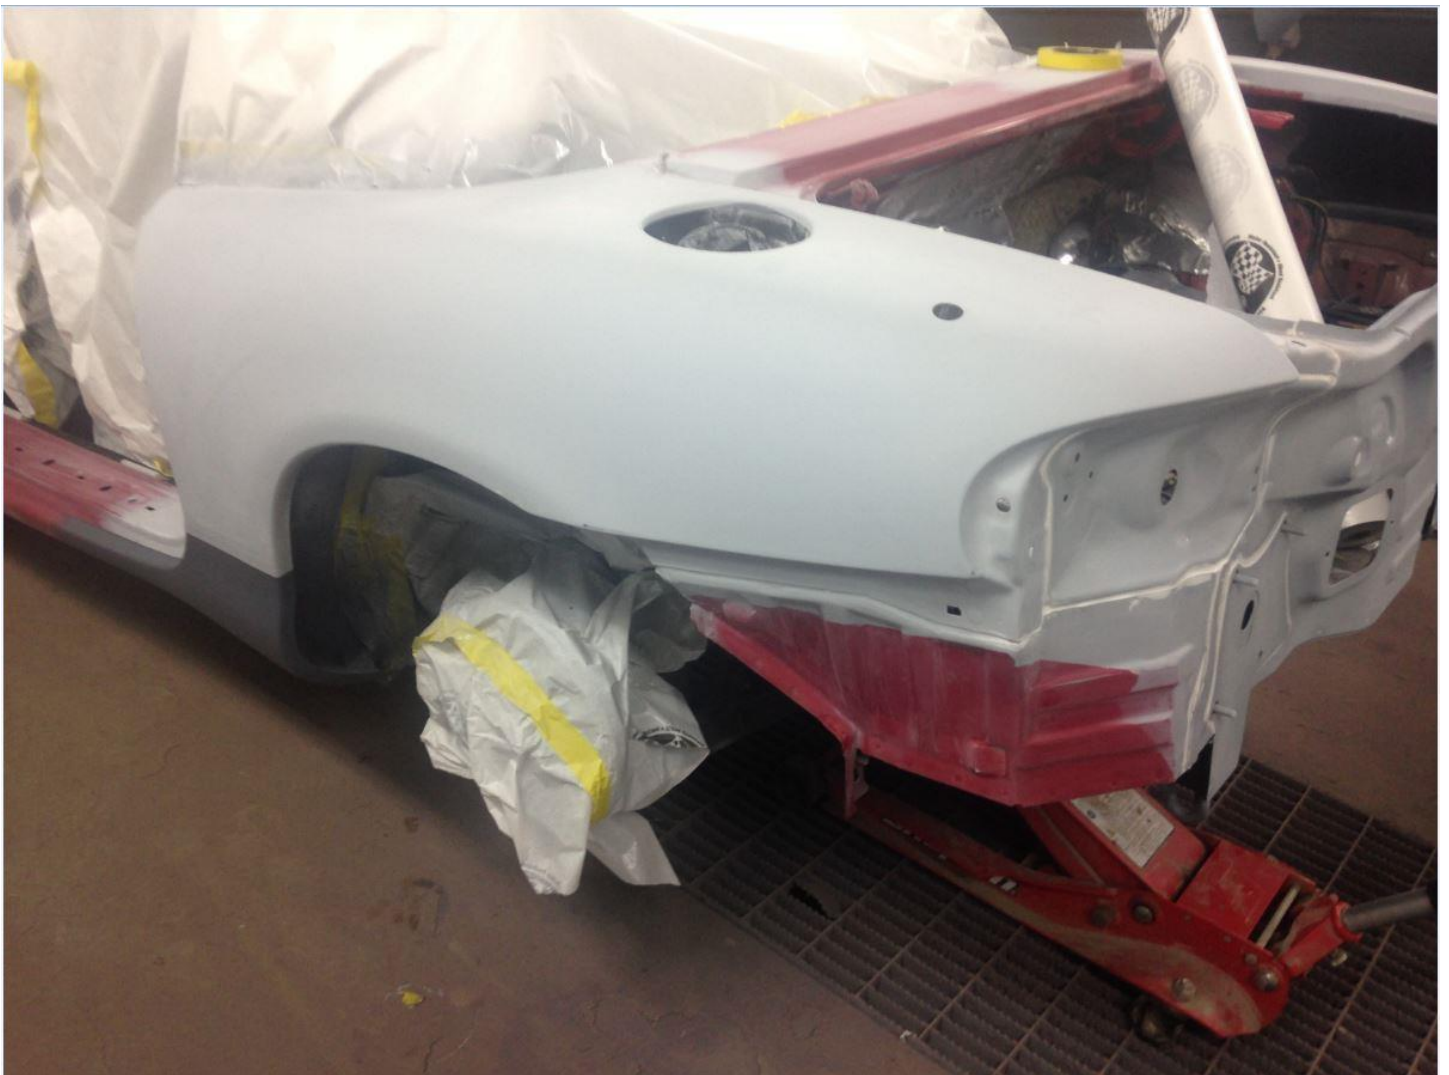
Rocker guard applied to new rear quarters - Oct 26th 2017.

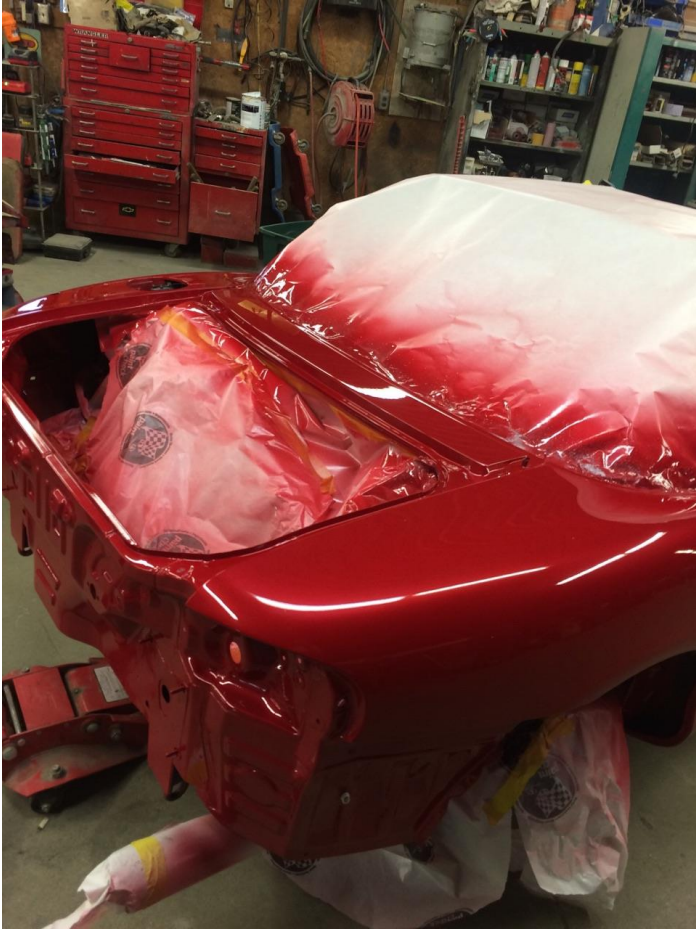
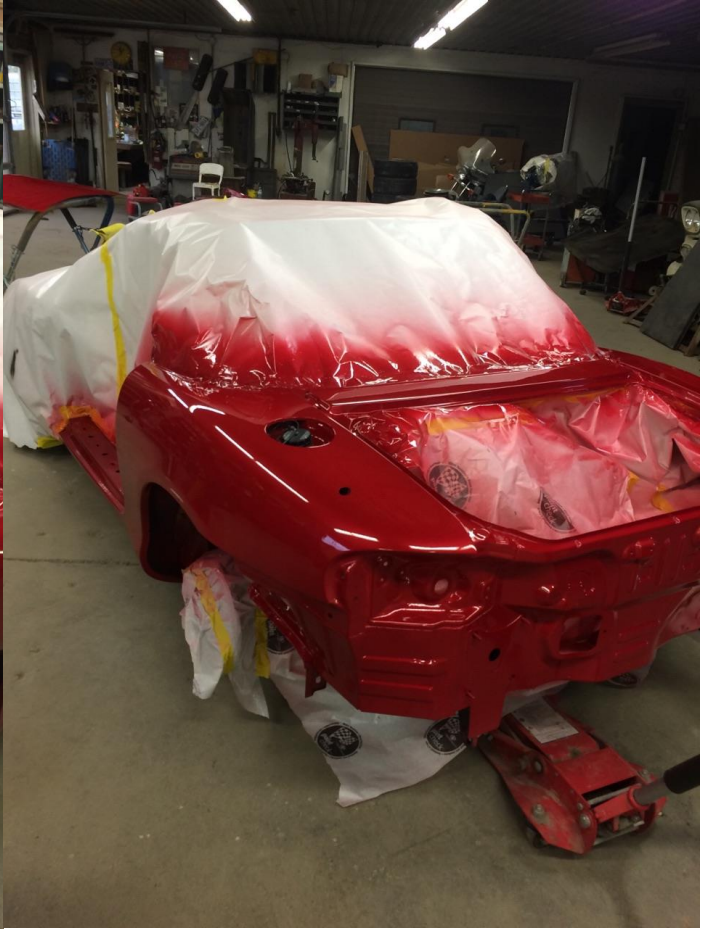
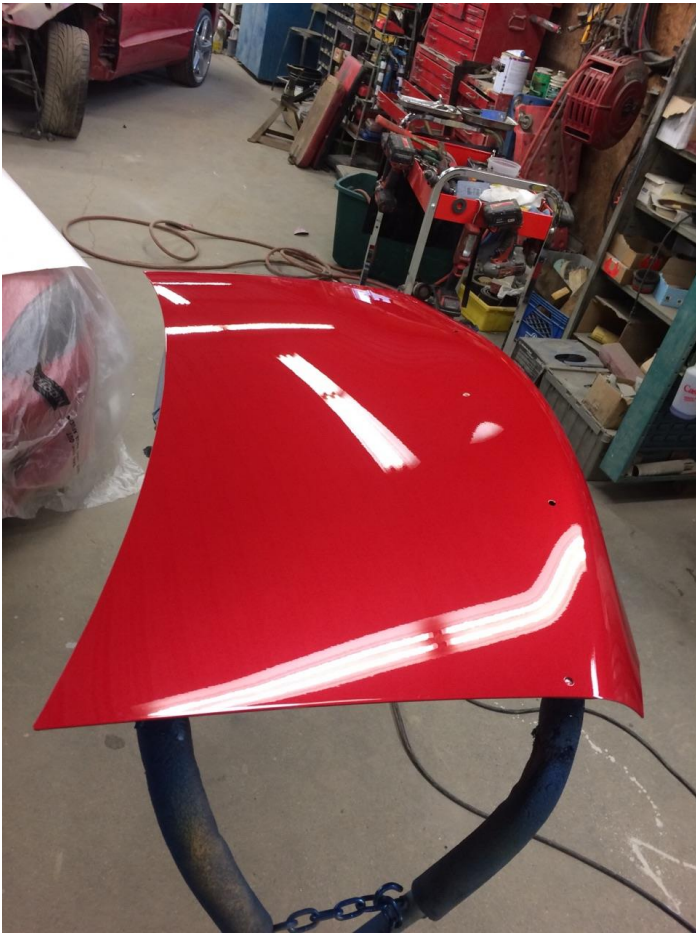
Paint has been applied – October 30th, 2017. Not quite 2 months since collision.

New paint and clear coat applied rear quarters and rear panel Oct 30st 2017. Bumper, new taillights and 3rd brake light all fitted on 31st.

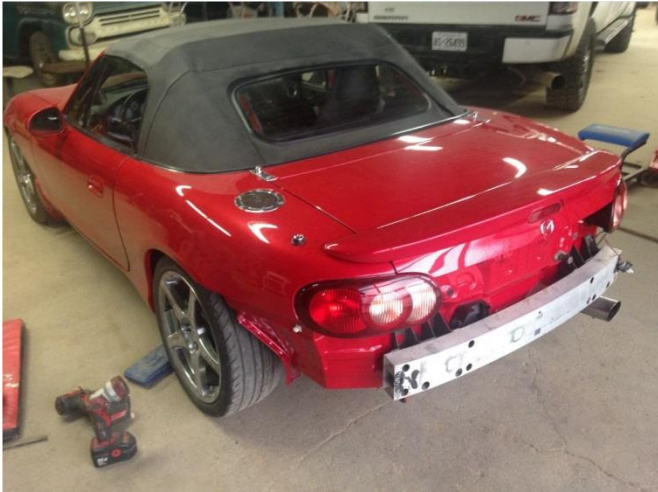
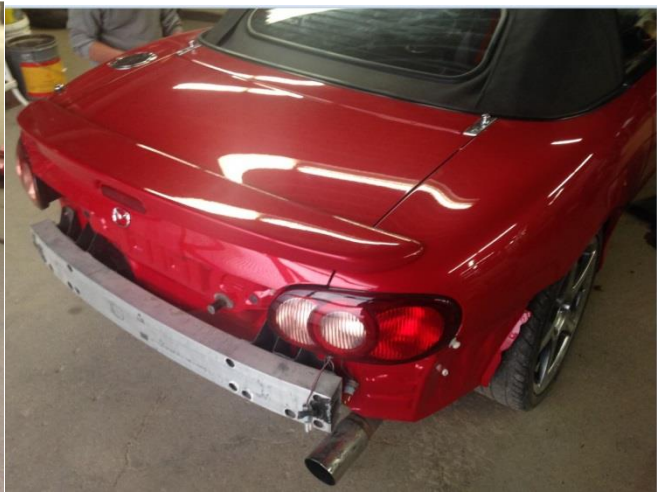
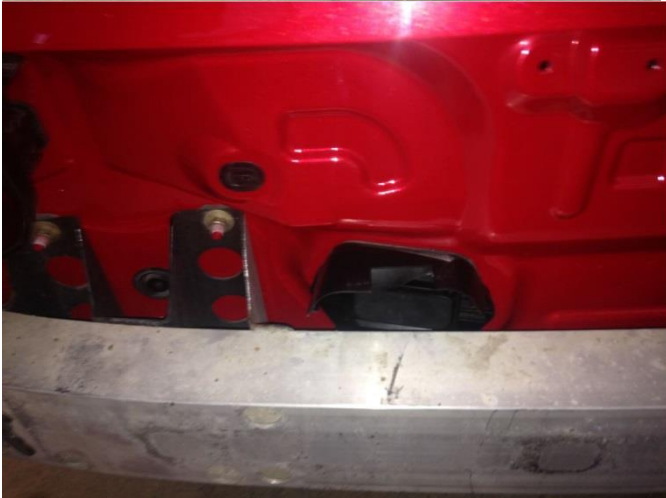
Note doors are just a little darker than new quarters as they already had paint on them (it's minor but noticeable).

Further application of paint was needed on front of rear quarter panels to blend them in. LSD Differential is back in with replacement carrier. New tires and alignment still to do. Starting to look good again.

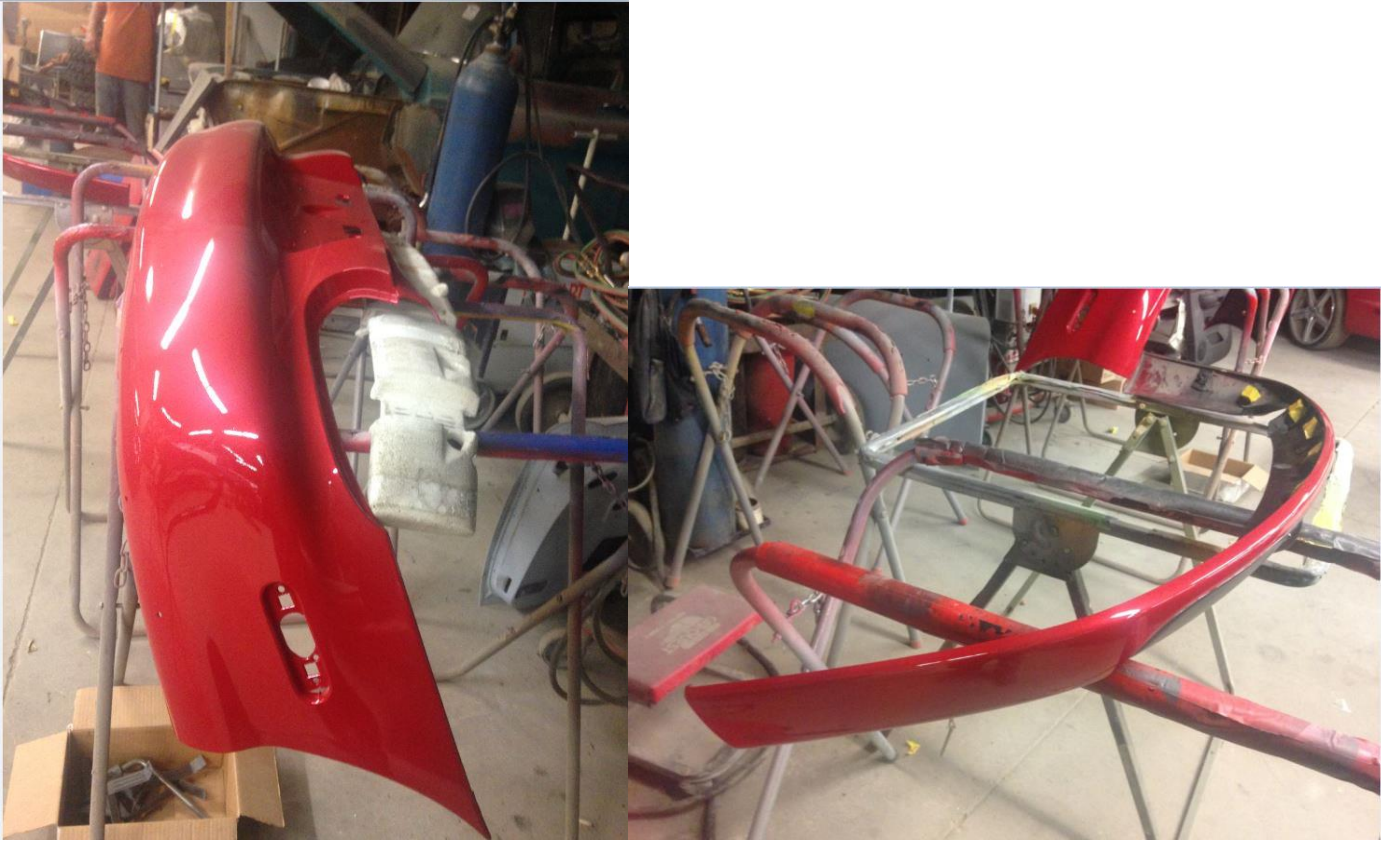
New bumper cover and original valance/diffuser painted – Nov 2, 2017

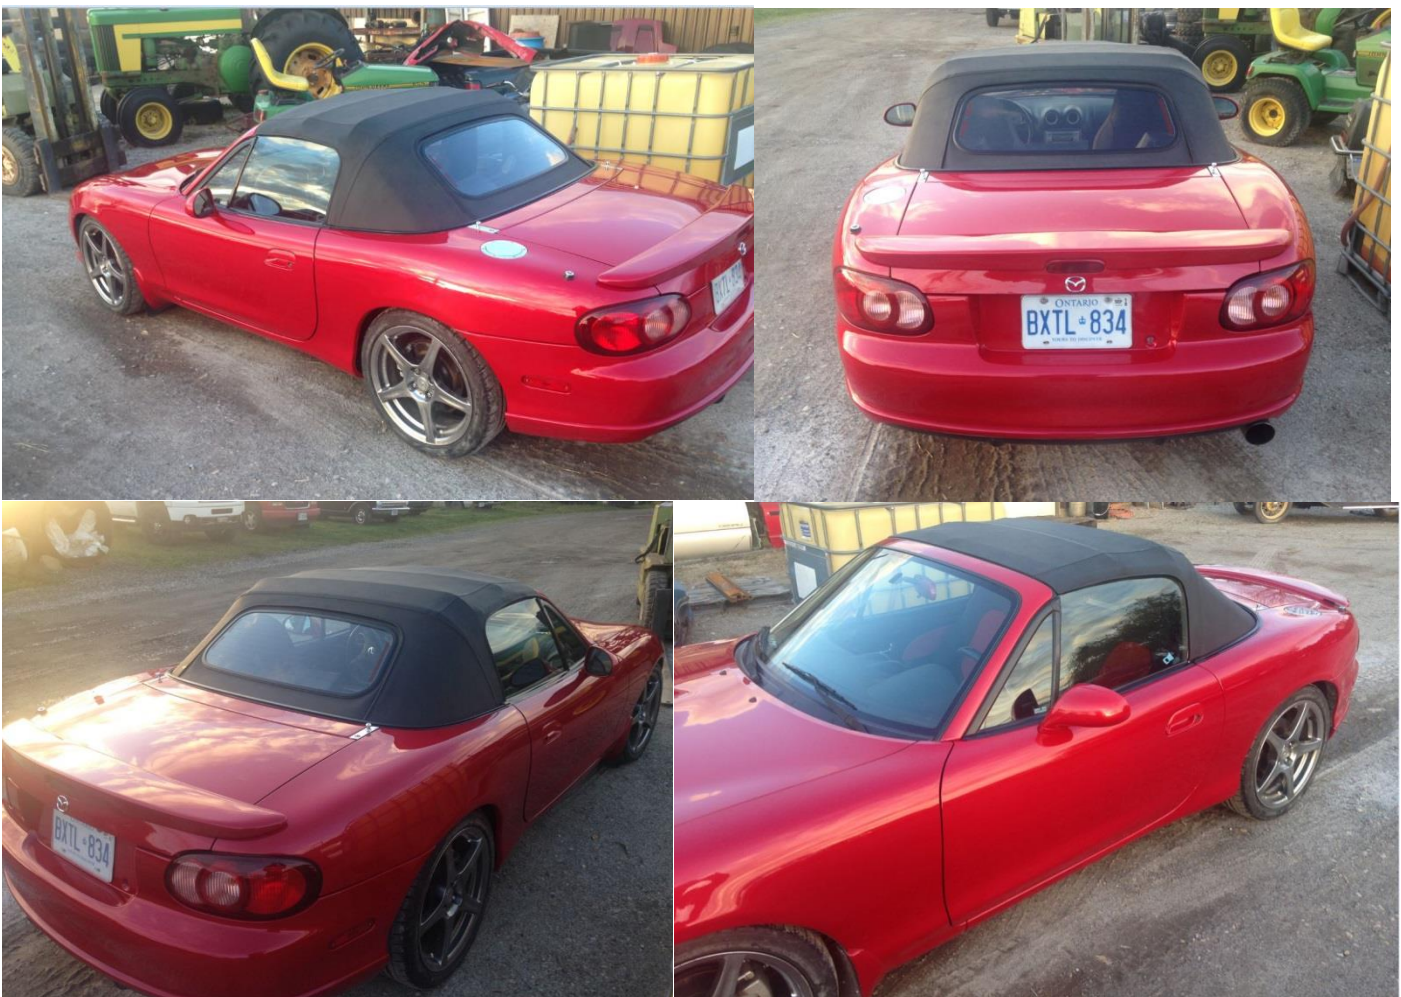
Car all painted and back together sans all emblems on trunk lid – Nov 7 2017. Note that bumper cover is a little low on passenger side. It was adjusted higher later. Other panel gaps are all good.

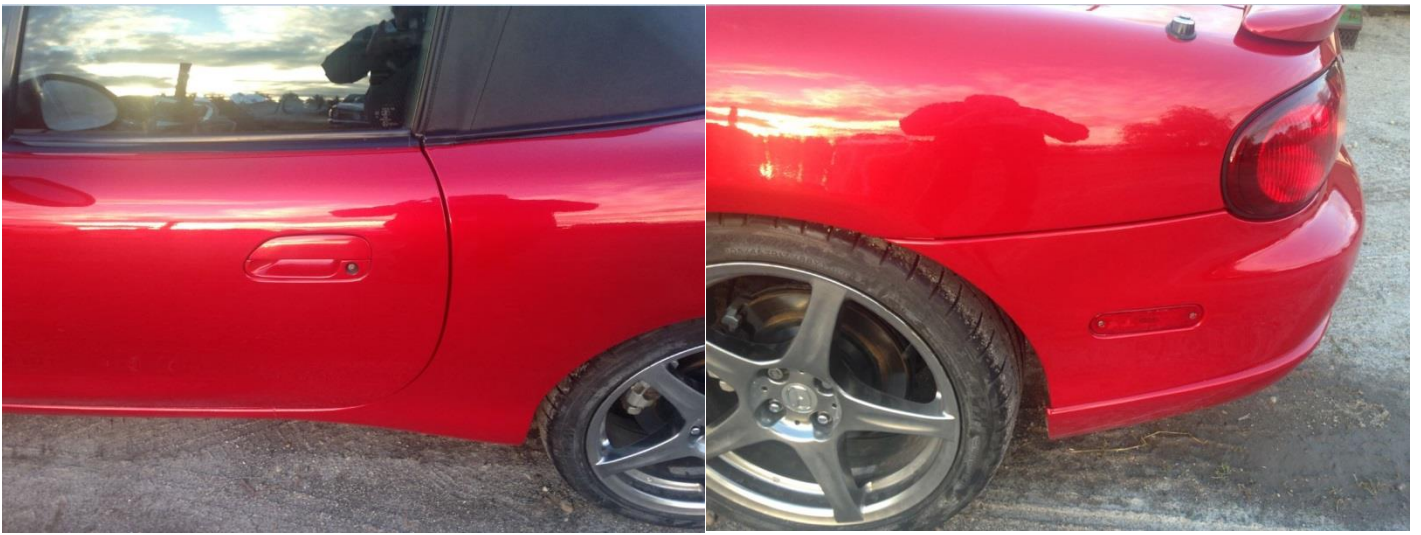
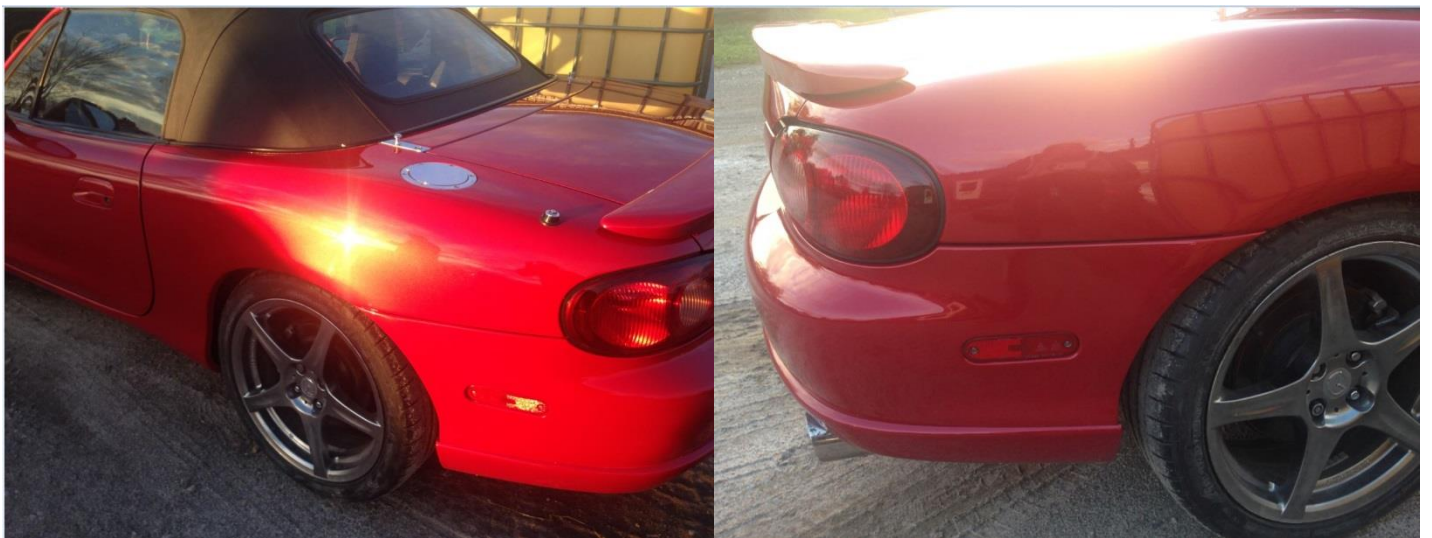
Note: new Michelin Pilot Super Sport tires are now on car. Alignment done close to 949Racing Street Spec. 1/16" toe in and -1.3 camber on rear.

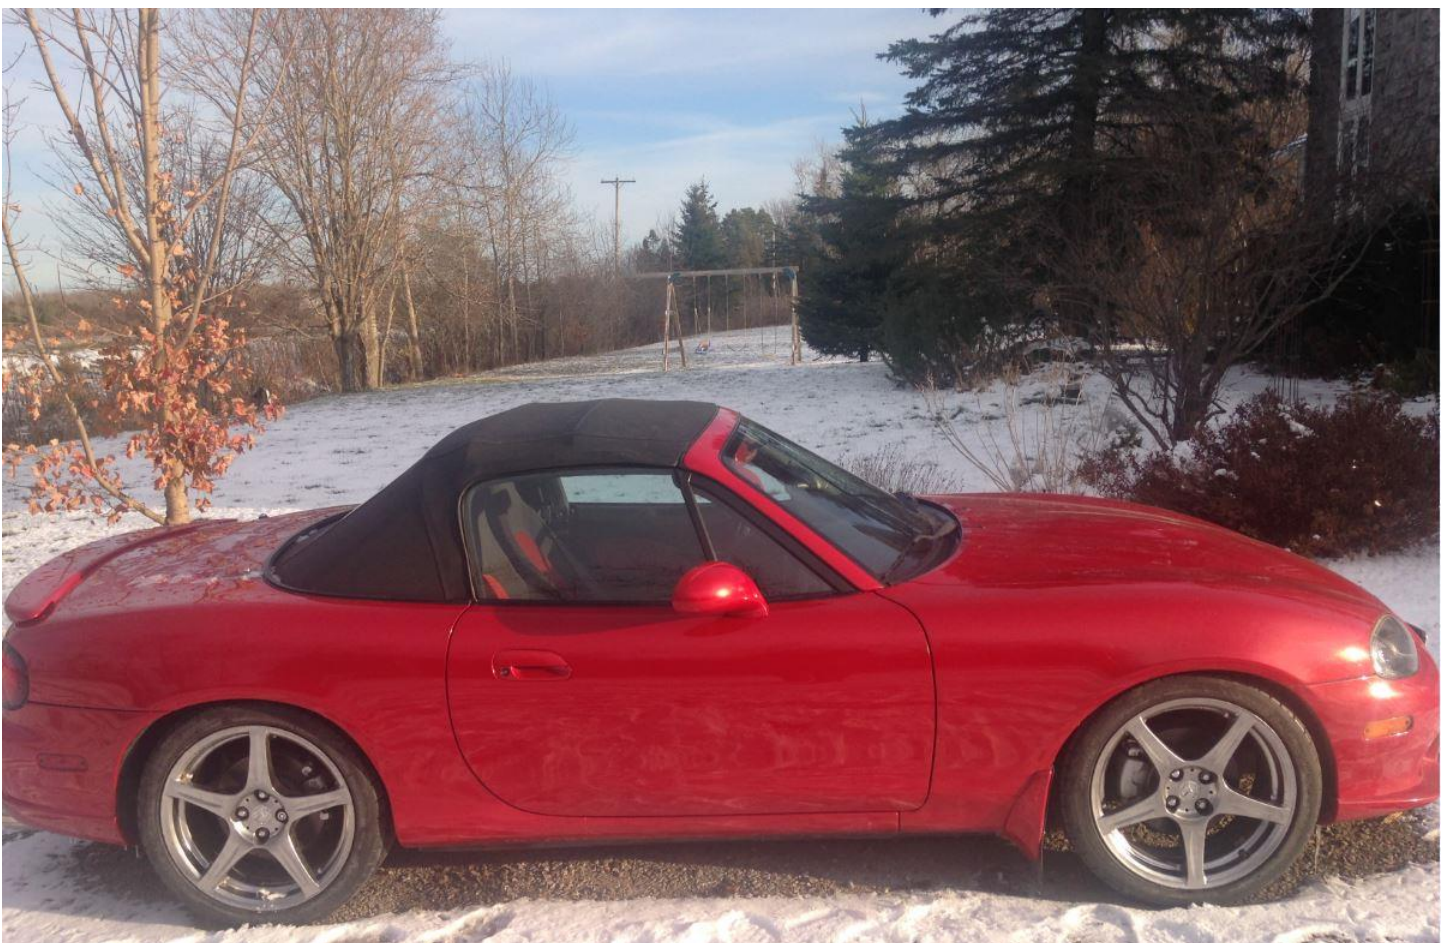
Car back home all done Nov 10th 2017. Damn if it did not snow overnight. Have to wait to test drive it some more

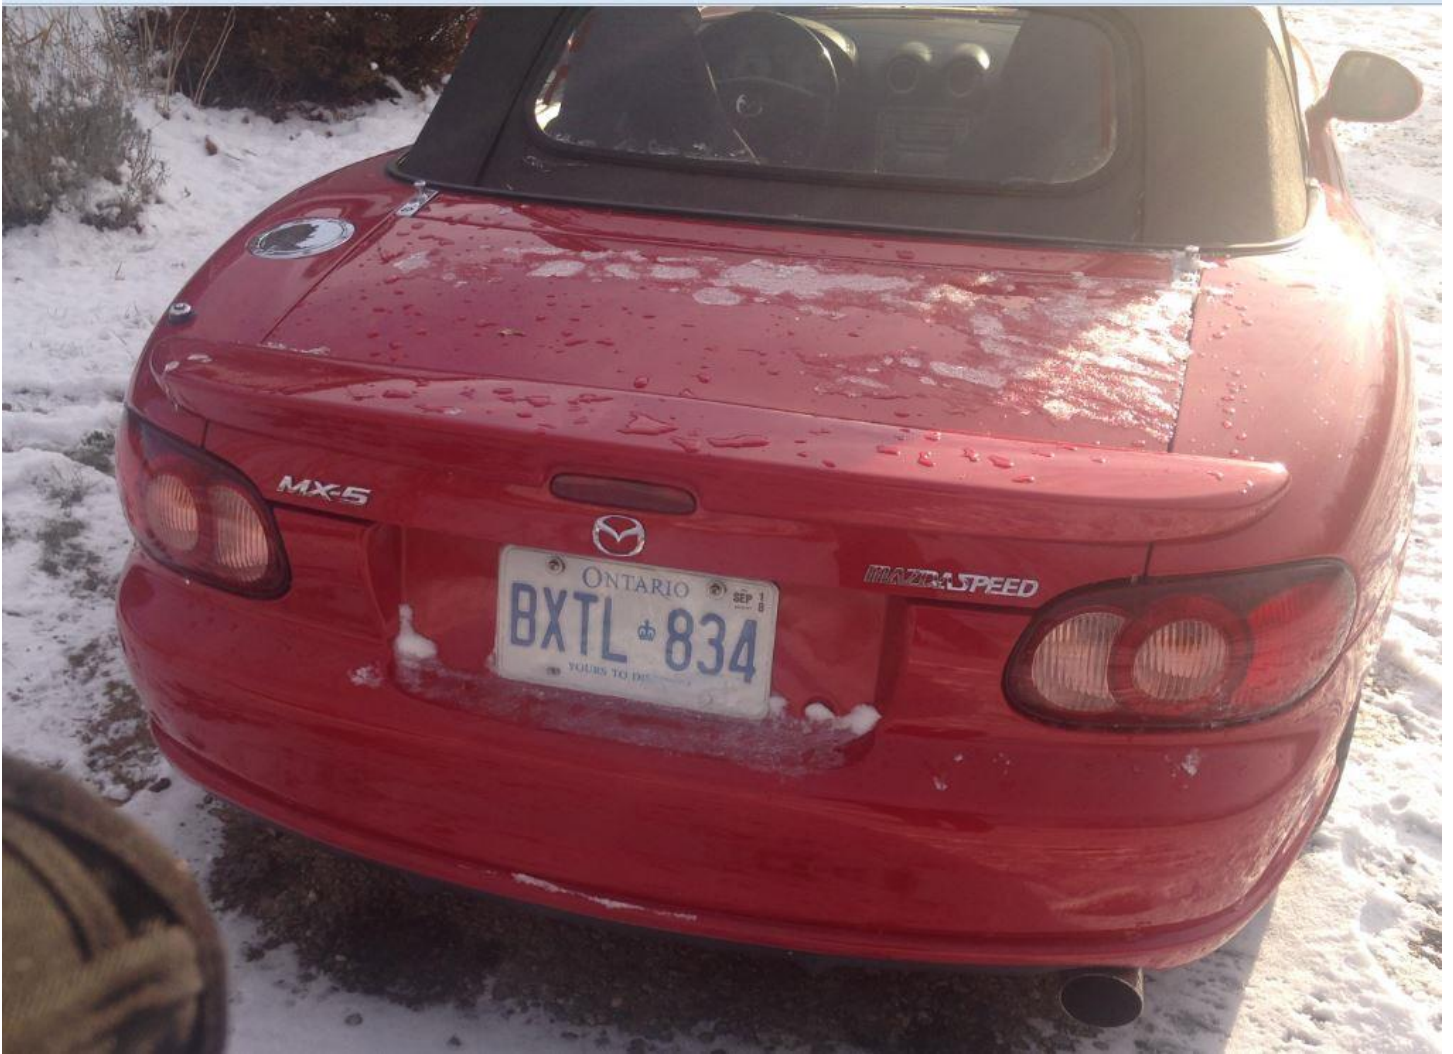
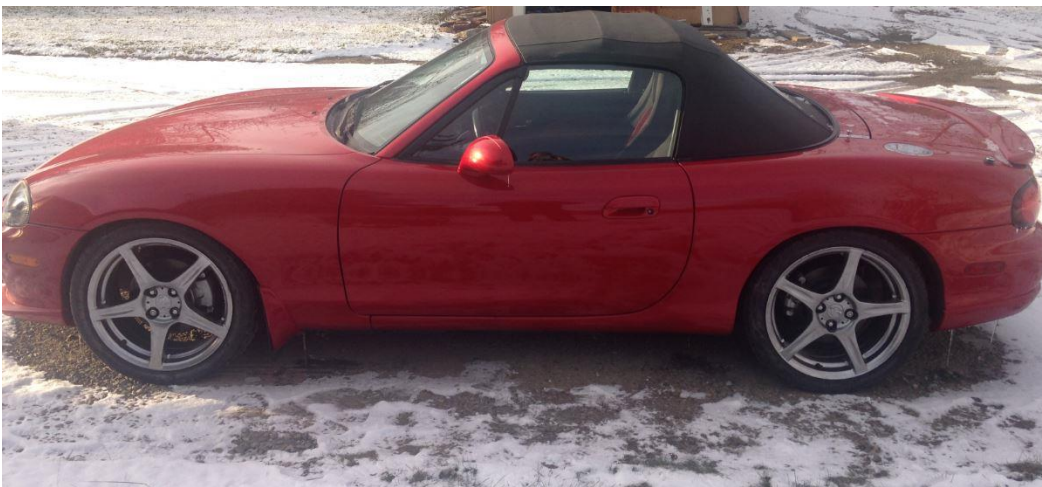
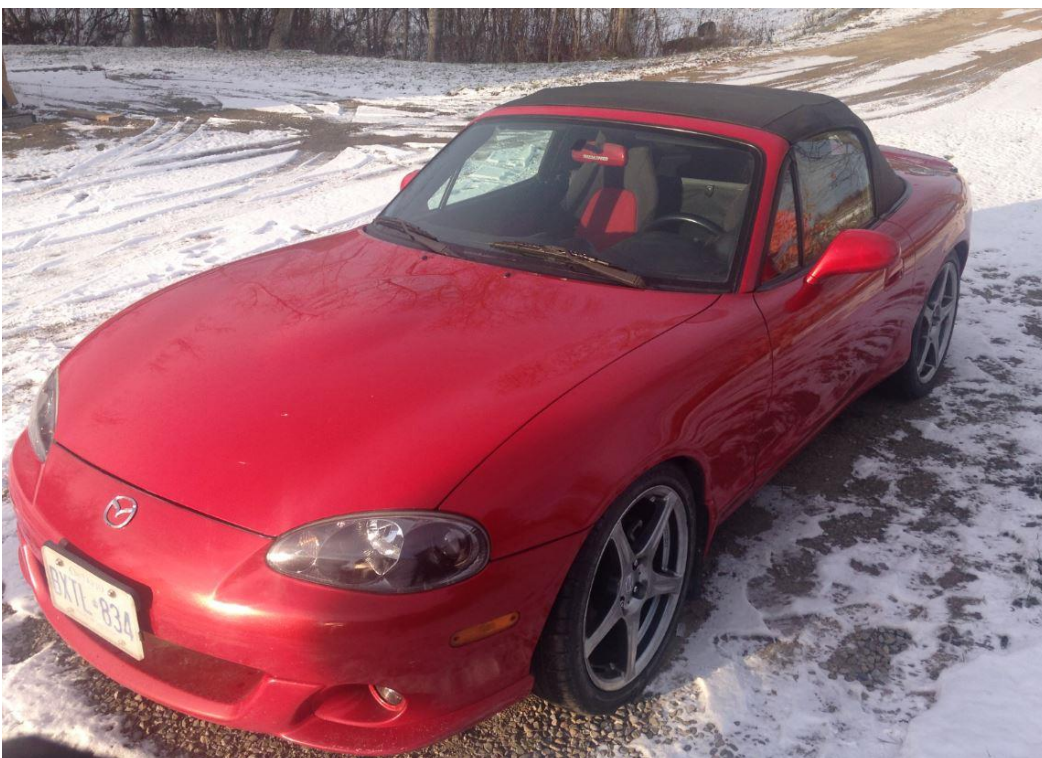
Rear emblems are all on. It's all back together just in time to put it away for the winter. Old silver hard top from my old 2003 Miata to go to Theaker's for painting in a week to match the MSM.
